NEW YORK STATE DEPARTMENT OF ENVIRONMENTAL CONSERVATION

Re: **Notice of Condition Rating – Unsound, Deficiency Recognized**
Chazy Lake Dam
DEC Dam ID#: 199-0282
Dannemora (T), Clinton County

Visual Observations

DAM NAME	Chazy Lake Dam			
STATE ID	199-0282	SECTION	D	HAZARD CODE
COUNTY	Clinton			C
NEAREST DS CITY/TOWN	Jerusalem			INSPECTION DATE
OWNER'S NAME	TOWN OF DANNEMORA			8/15/2019
				INSPECTOR(S)
				SNA/MLH
DOWNSTREAM HAZARD	High			TOWNSHIP
				Town of Dannemora

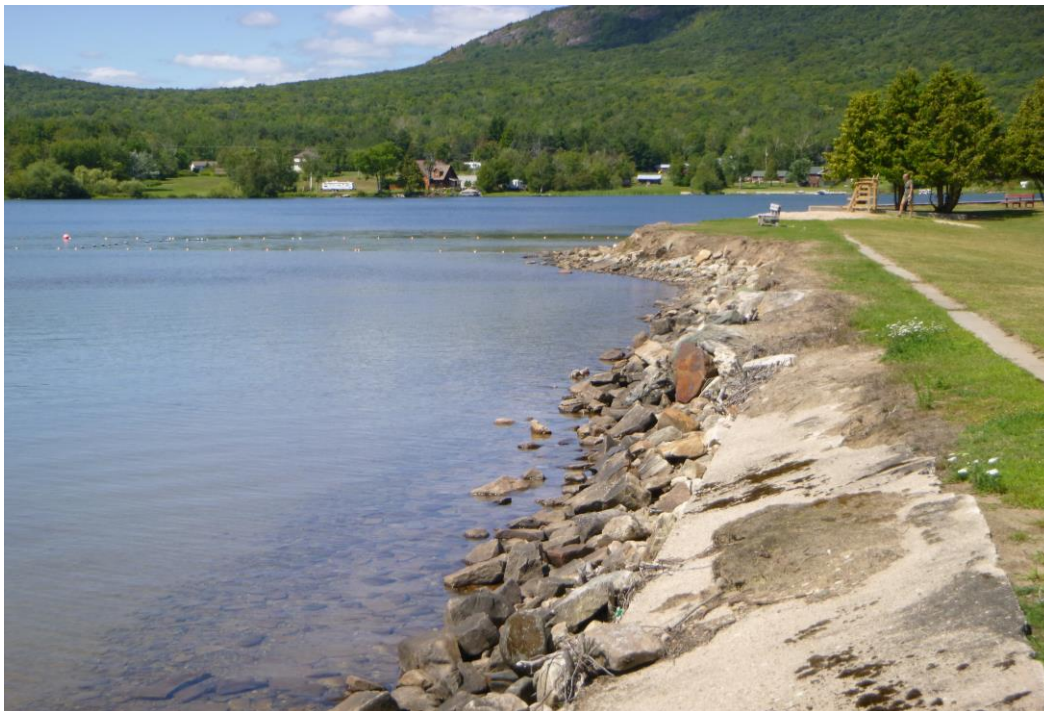
Photo 1 Dam ID# 199-0282 Chazy Lake Dam 08/15/2019
Upstream slope of right dam

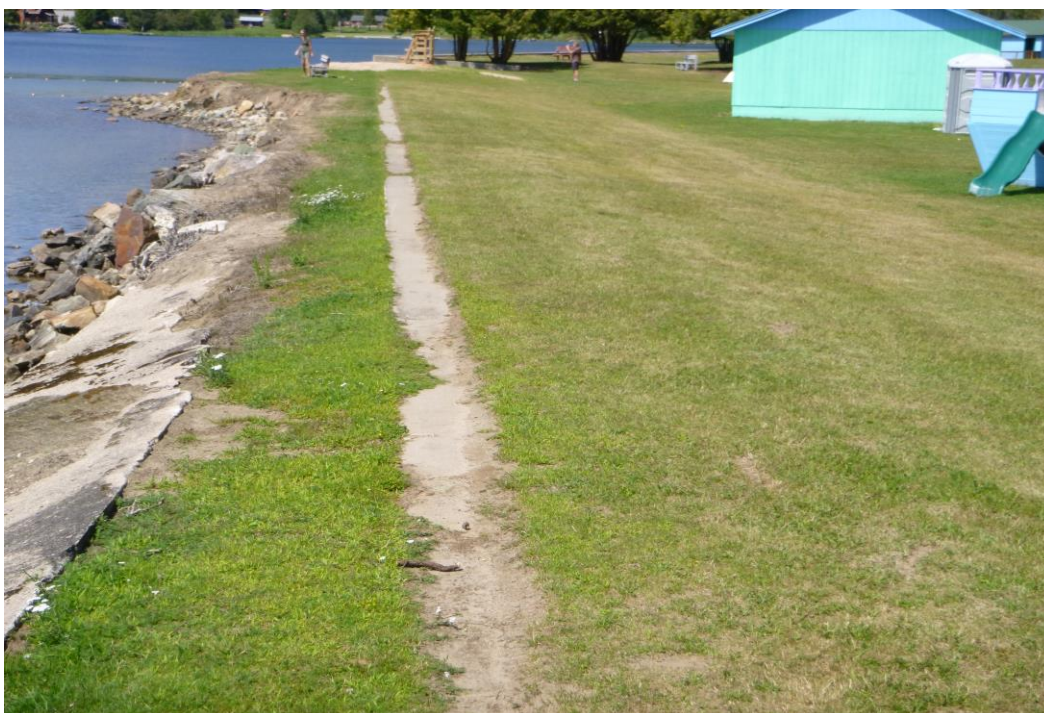
Photo 2 Dam ID# 199-0282 Chazy Lake Dam 08/15/2019
Right dam crest

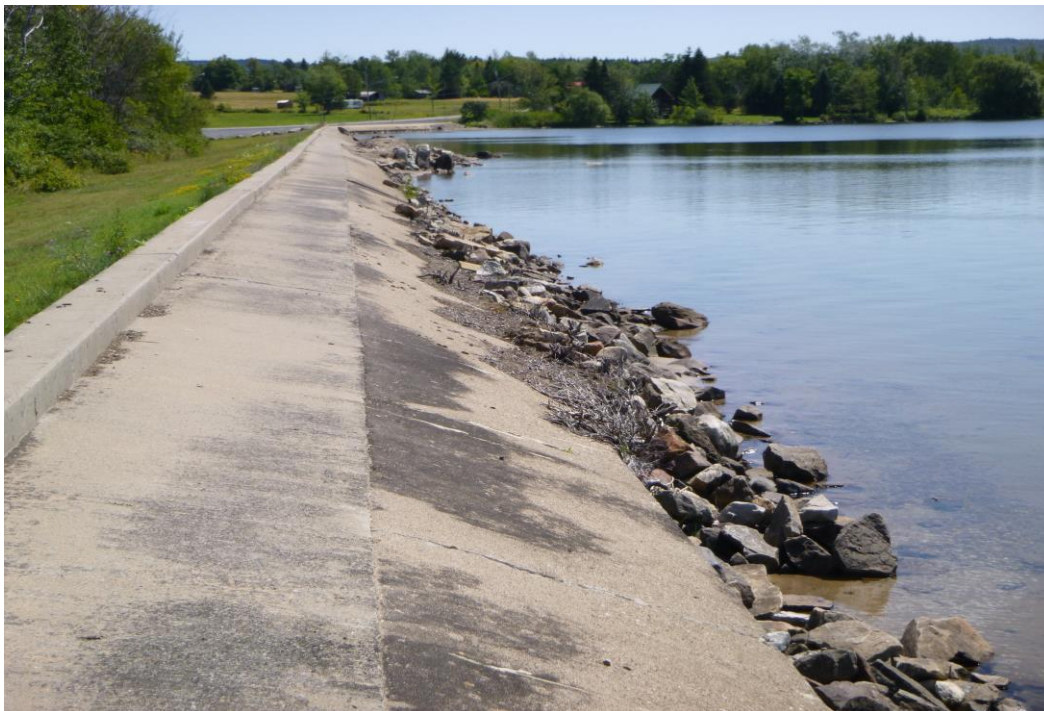
Photo 3 Dam ID# 199-0282 Chazy Lake Dam 08/15/2019
Upstream slope of right dam

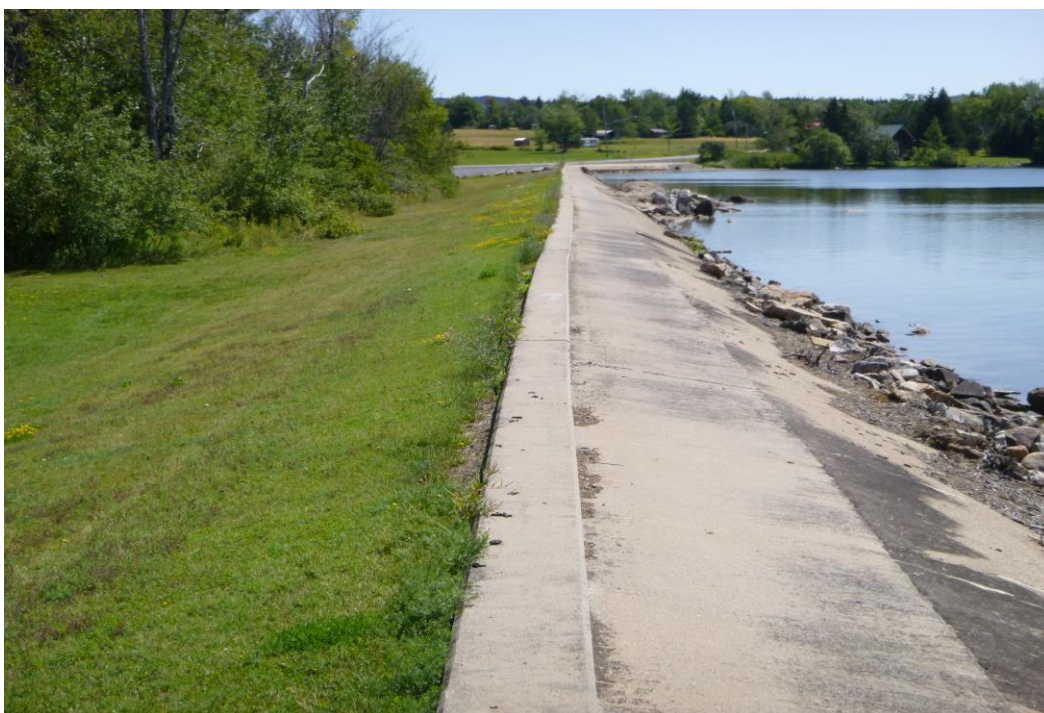
Photo 4 Dam ID# 199-0282 Chazy Lake Dam 08/15/2019
Right dam crest

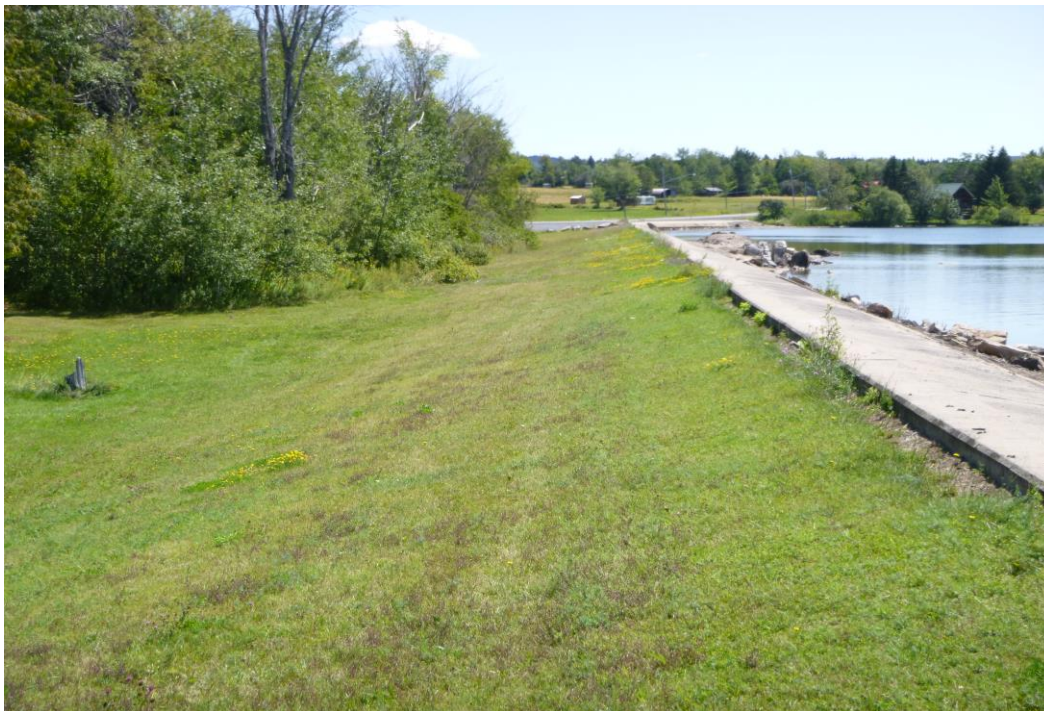
Photo 5 Dam ID# 199-0282 Chazy Lake Dam 08/15/2019
Downstream slope of right dam

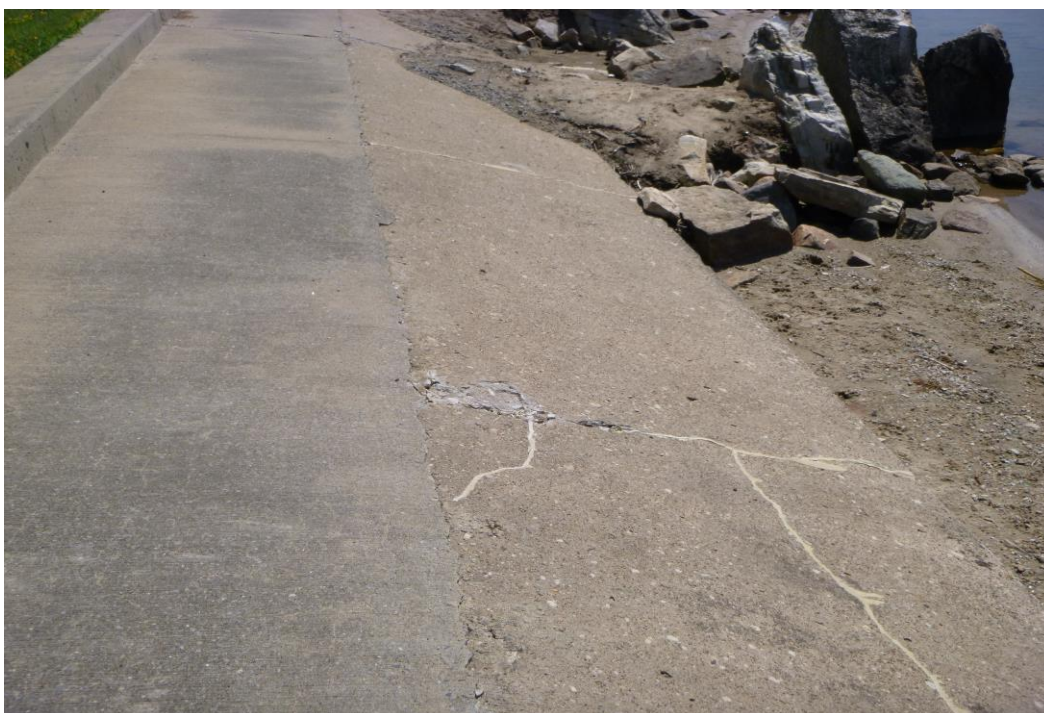
- Inspected with Eric Whitman (town staff)
- Right dam:
 - creacked and spalled concrete on upstream slope
- Auxiliaary spillway:
 - earth erosion upstream of spillway
- Mid dam:
 - Well maintained
- Left dam:
 - No erosion resistant cover on downstream slope

Photo 6 Dam ID# 199-0282 Chazy Lake Dam 08/15/2019
Deteriorated concrete on upstream slope of right dam

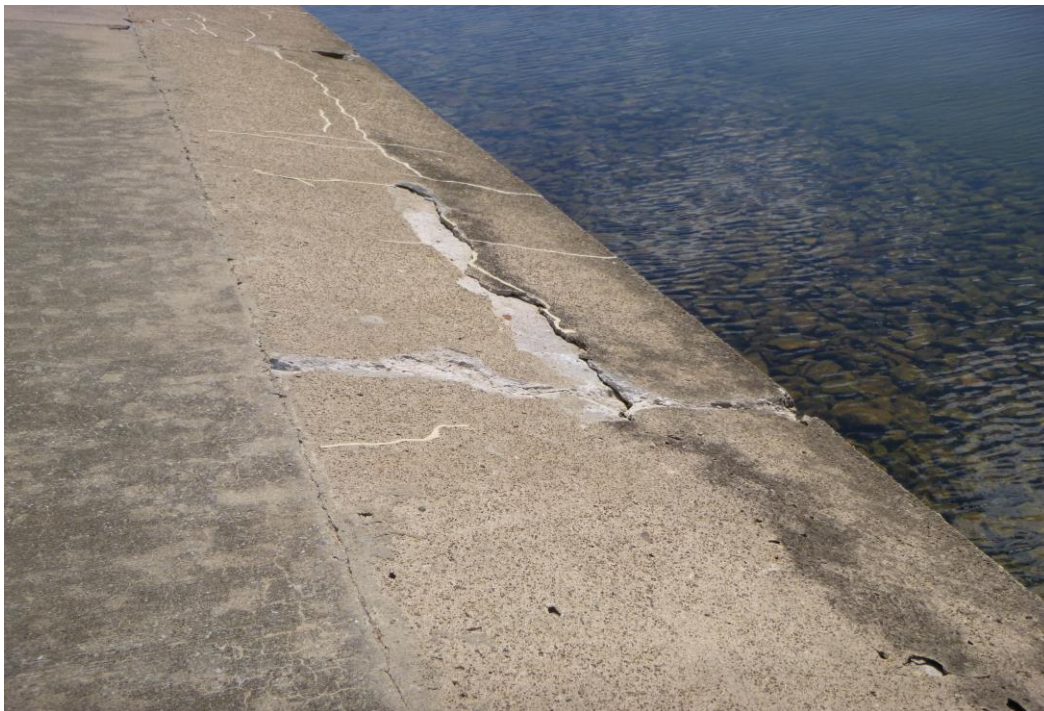
Photo 7 Dam ID# 199-0282 Chazy Lake Dam 08/15/2019
Deteriorated concrete on upstream slope of right dam

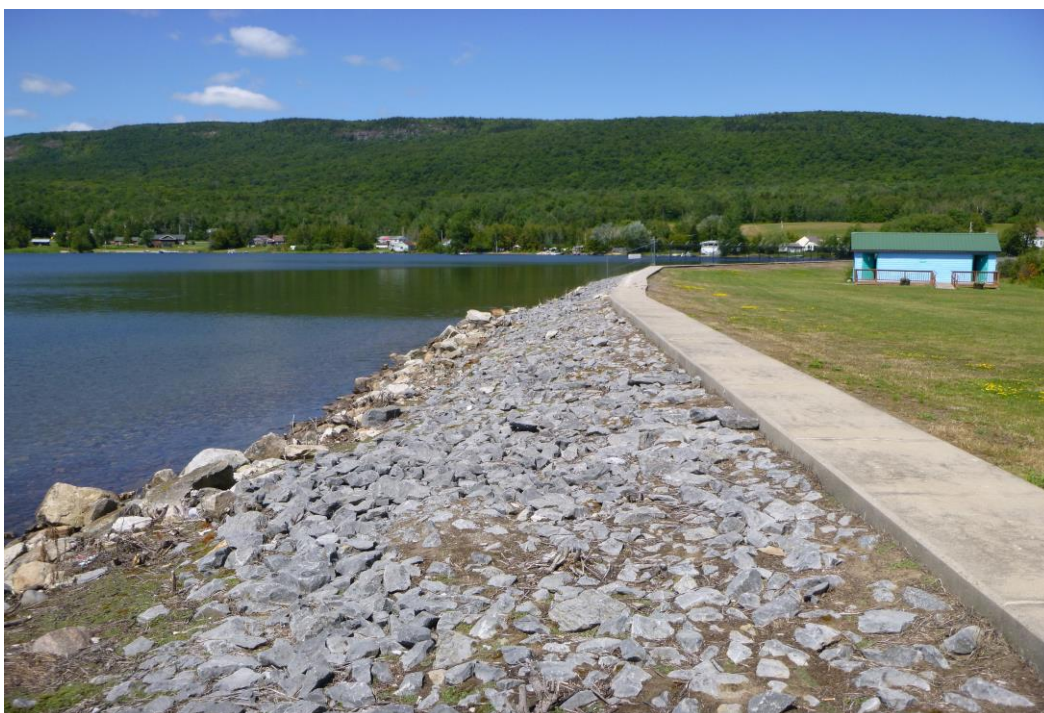
Photo 8 Dam ID# 199-0282 Chazy Lake Dam 08/15/2019
Upstream slope of mid dam

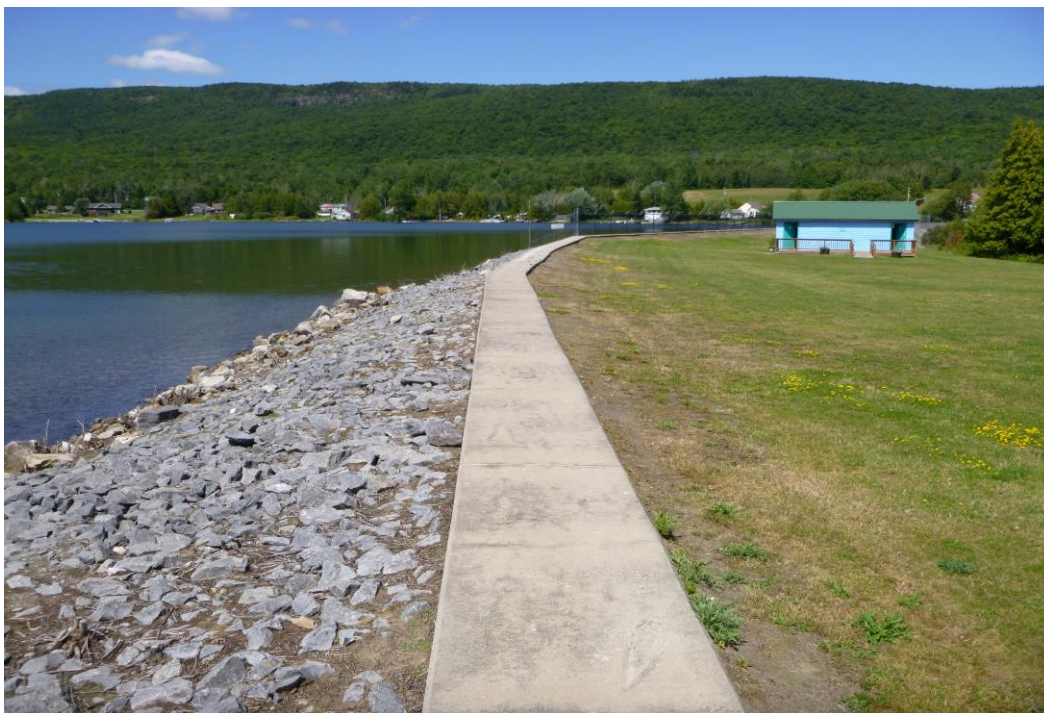
Photo 9 Dam ID# 199-0282 Chazy Lake Dam 08/15/2019
Mid dam crest

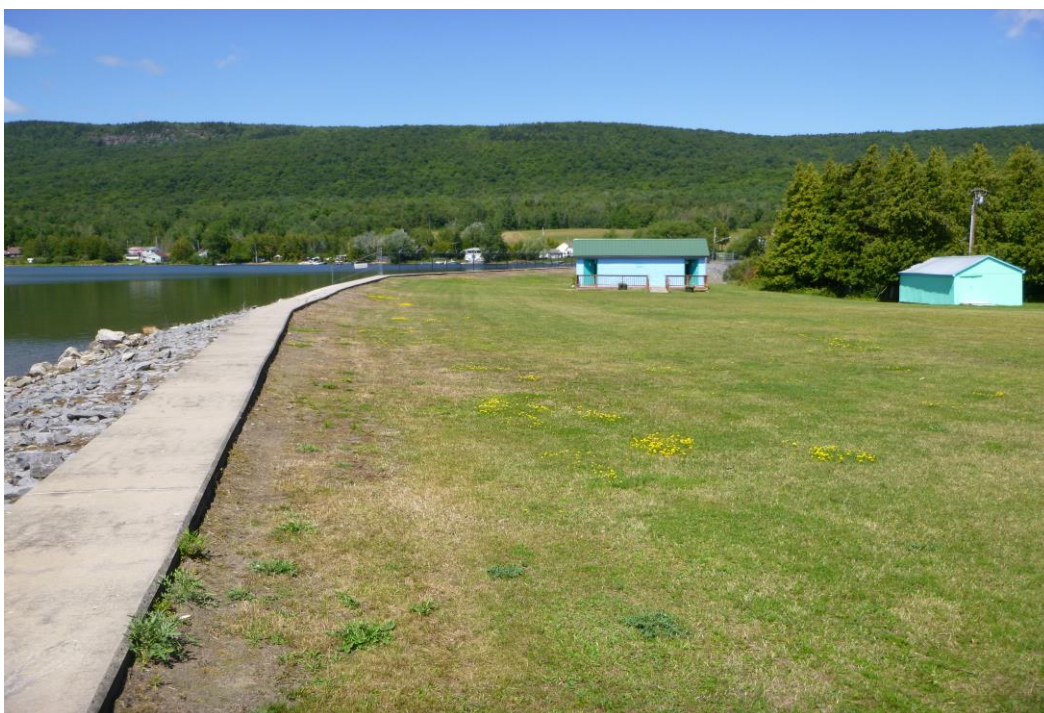
Photo 10 Dam ID# 199-0282 Chazy Lake Dam 08/15/2019
Downstream slope of mid dam

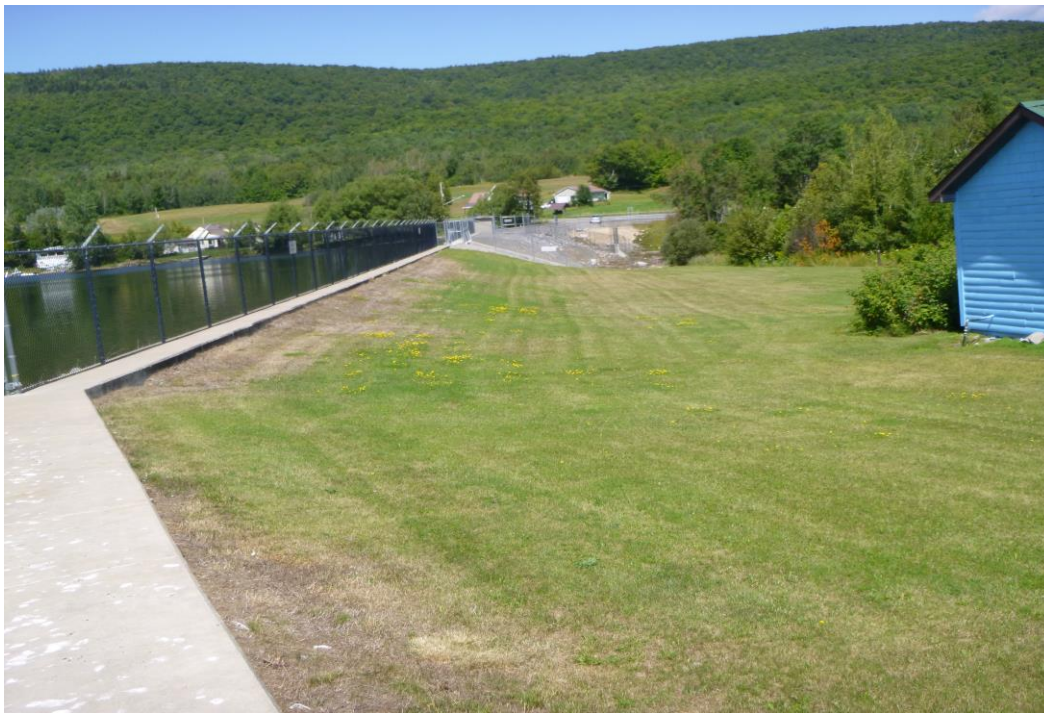
Photo 11 Dam ID# 199-0282 Chazy Lake Dam 08/15/2019
Downstream slope of mid dam

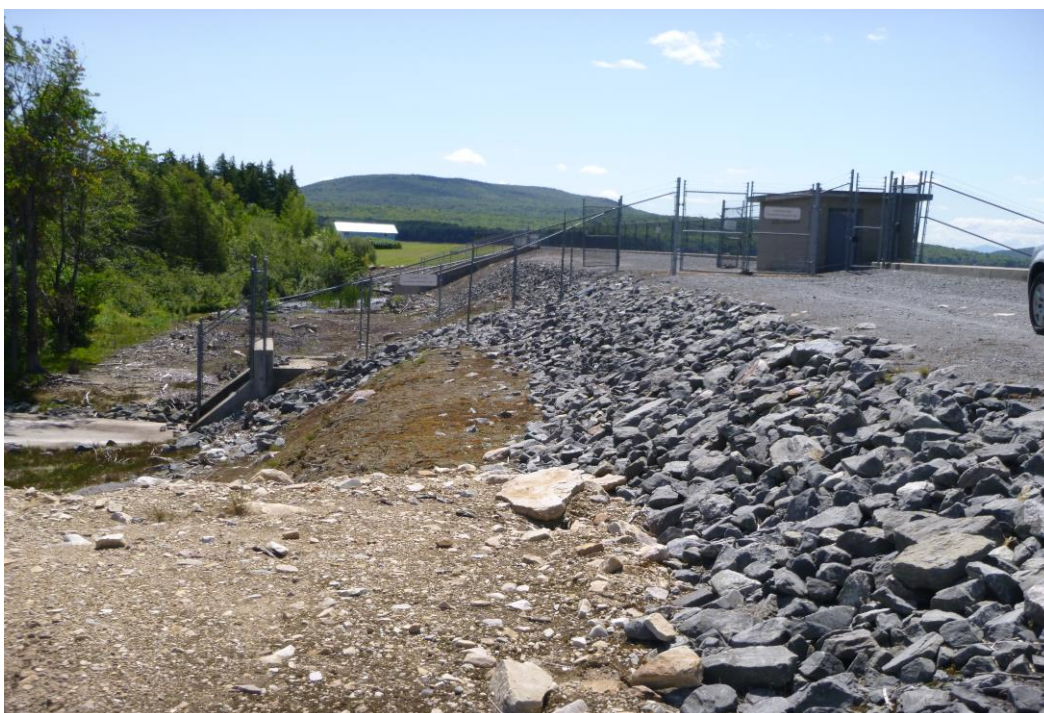
Photo 12 Dam ID# 199-0282 Chazy Lake Dam 08/15/2019
Downstream slope left dam

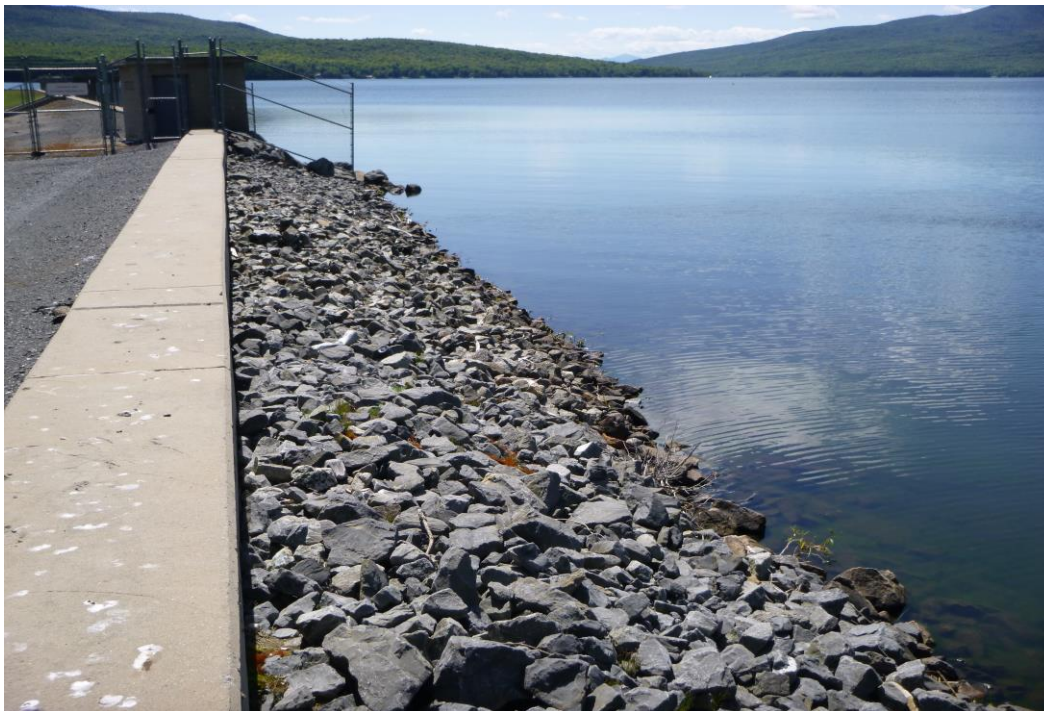
Photo 13 Dam ID# 199-0282 Chazy Lake Dam 08/15/2019
Upstream slope of left dam

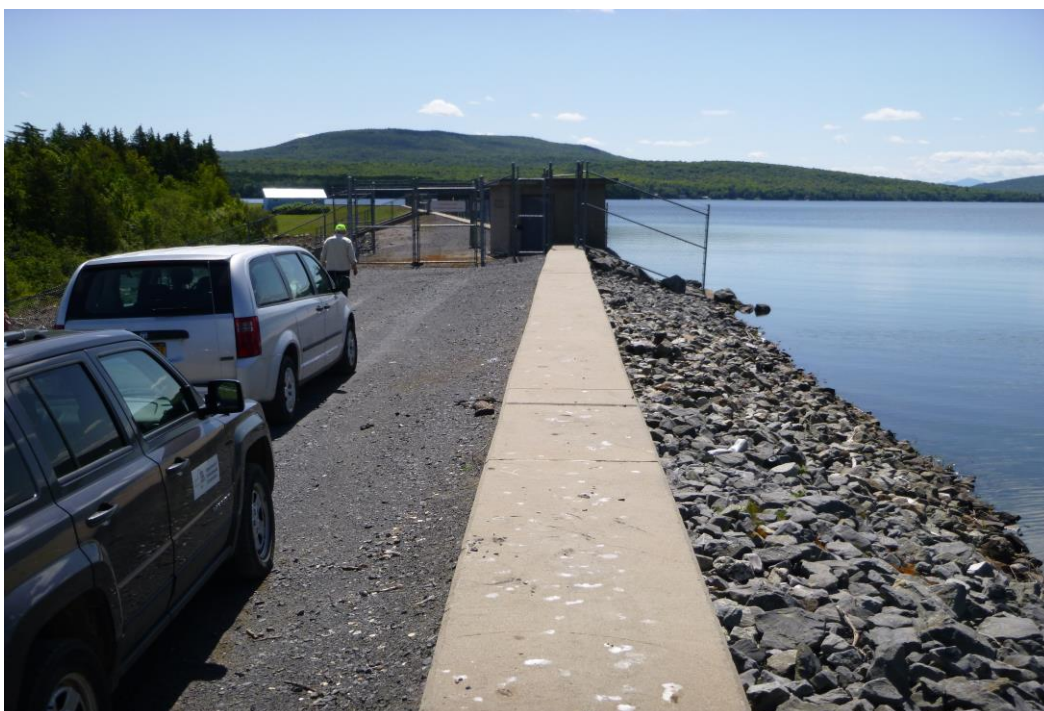
Photo 14 Dam ID# 199-0282 Chazy Lake Dam 08/15/2019
Left dam crest

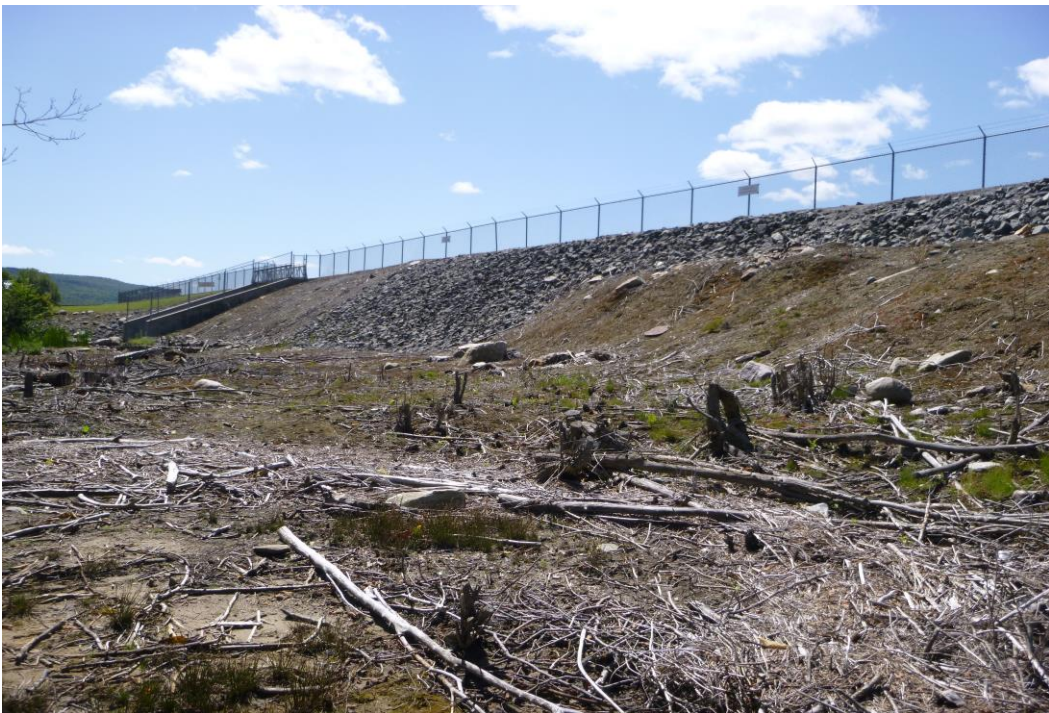
Photo 16 Dam ID# 199-0282 Chazy Lake Dam 08/15/2019
Downstream slope of left dam

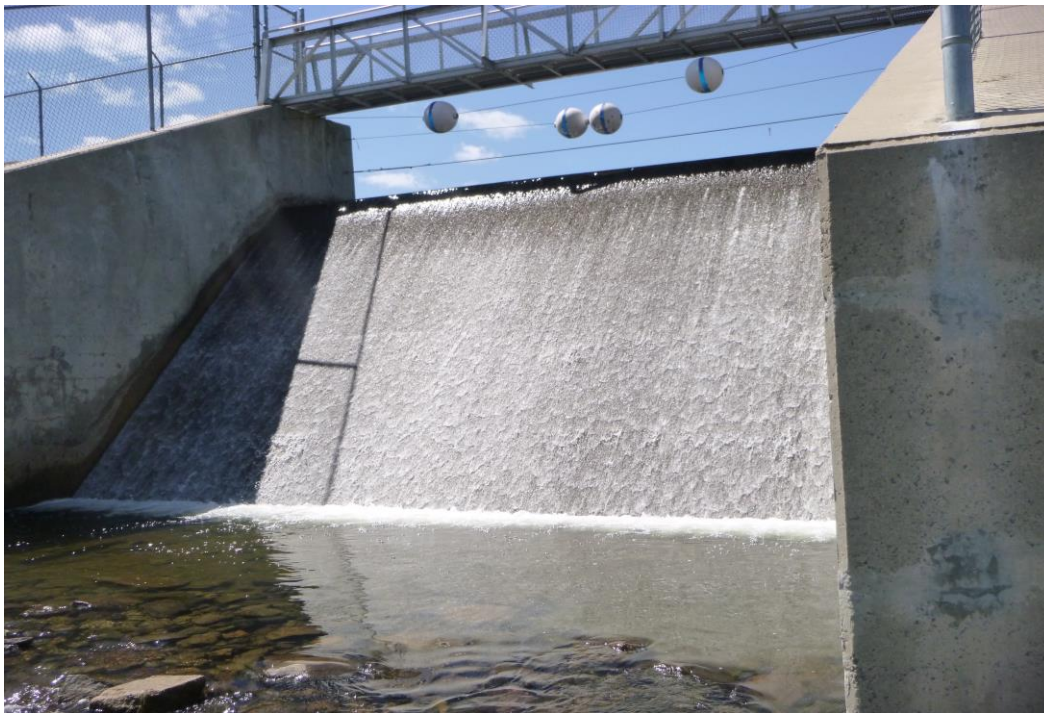
Photo 17 Dam ID# 199-0282 Chazy Lake Dam 08/15/2019
Downstream view of primary spillway

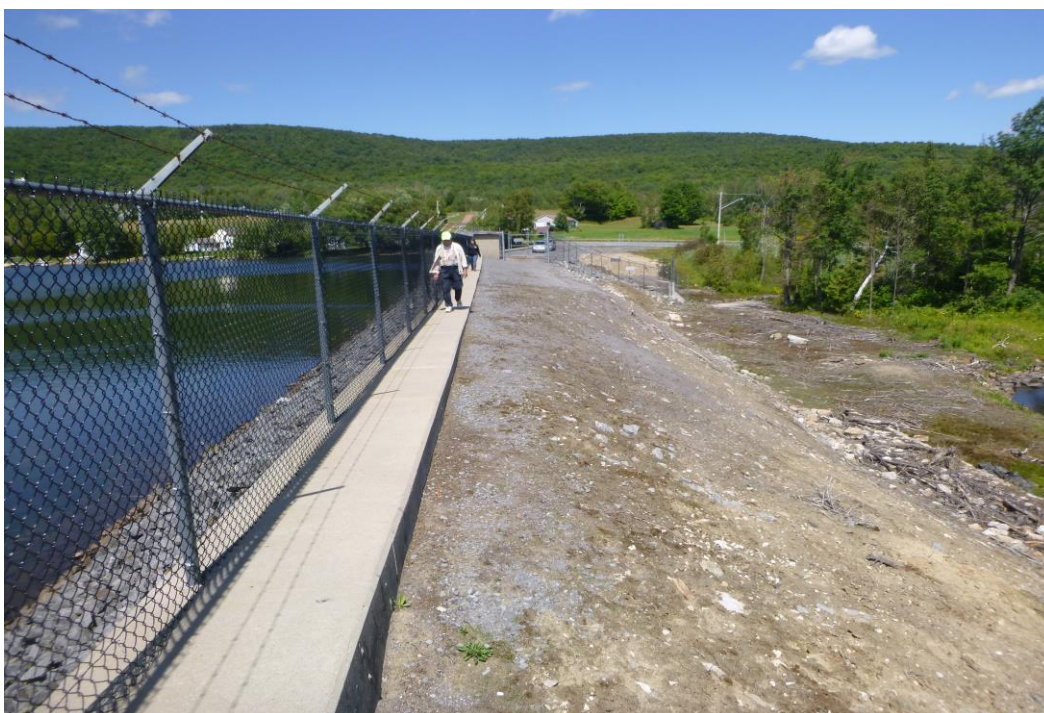
Photo 18 Dam ID# 199-0282 Chazy Lake Dam 08/15/2019
Downstream slope of left dam

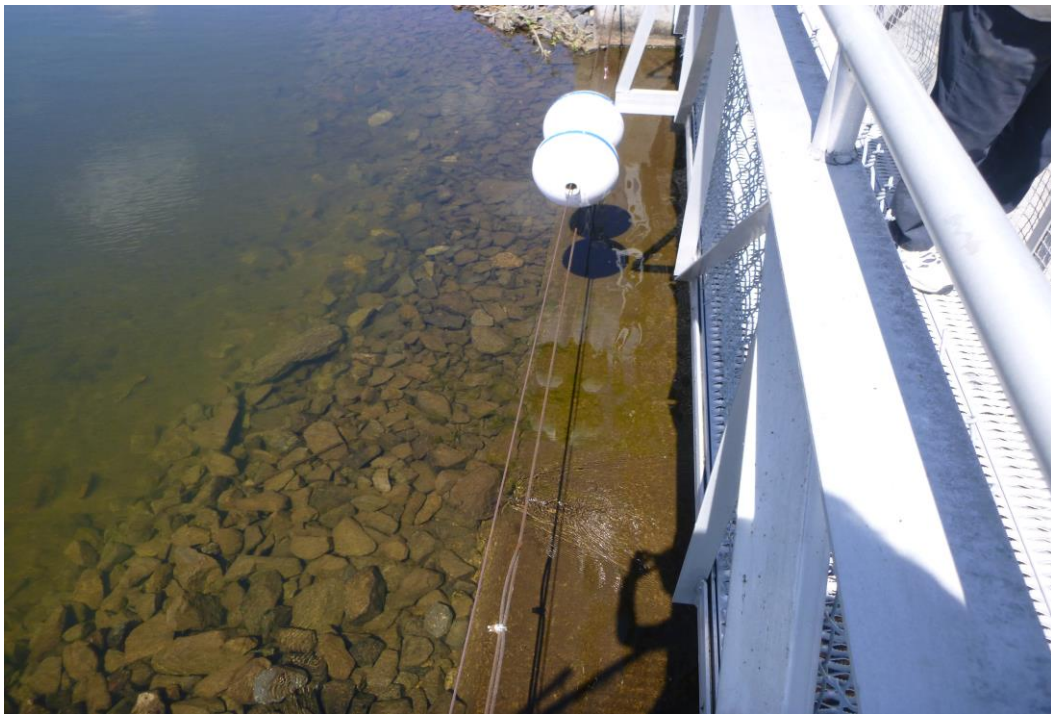
Photo 19 Dam ID# 199-0282 Chazy Lake Dam 08/15/2019
Upstream of primary spillway
