DAM REPORT

June 28, 1920
(Date)

I have the honor to make the following report in relation to the structure known as the Indian Lake Stone Dam Dam.

This dam is situated upon the Outlet of Indian Lake
(Give name of stream)
in the Town of Indian Lake, Hamilton County,

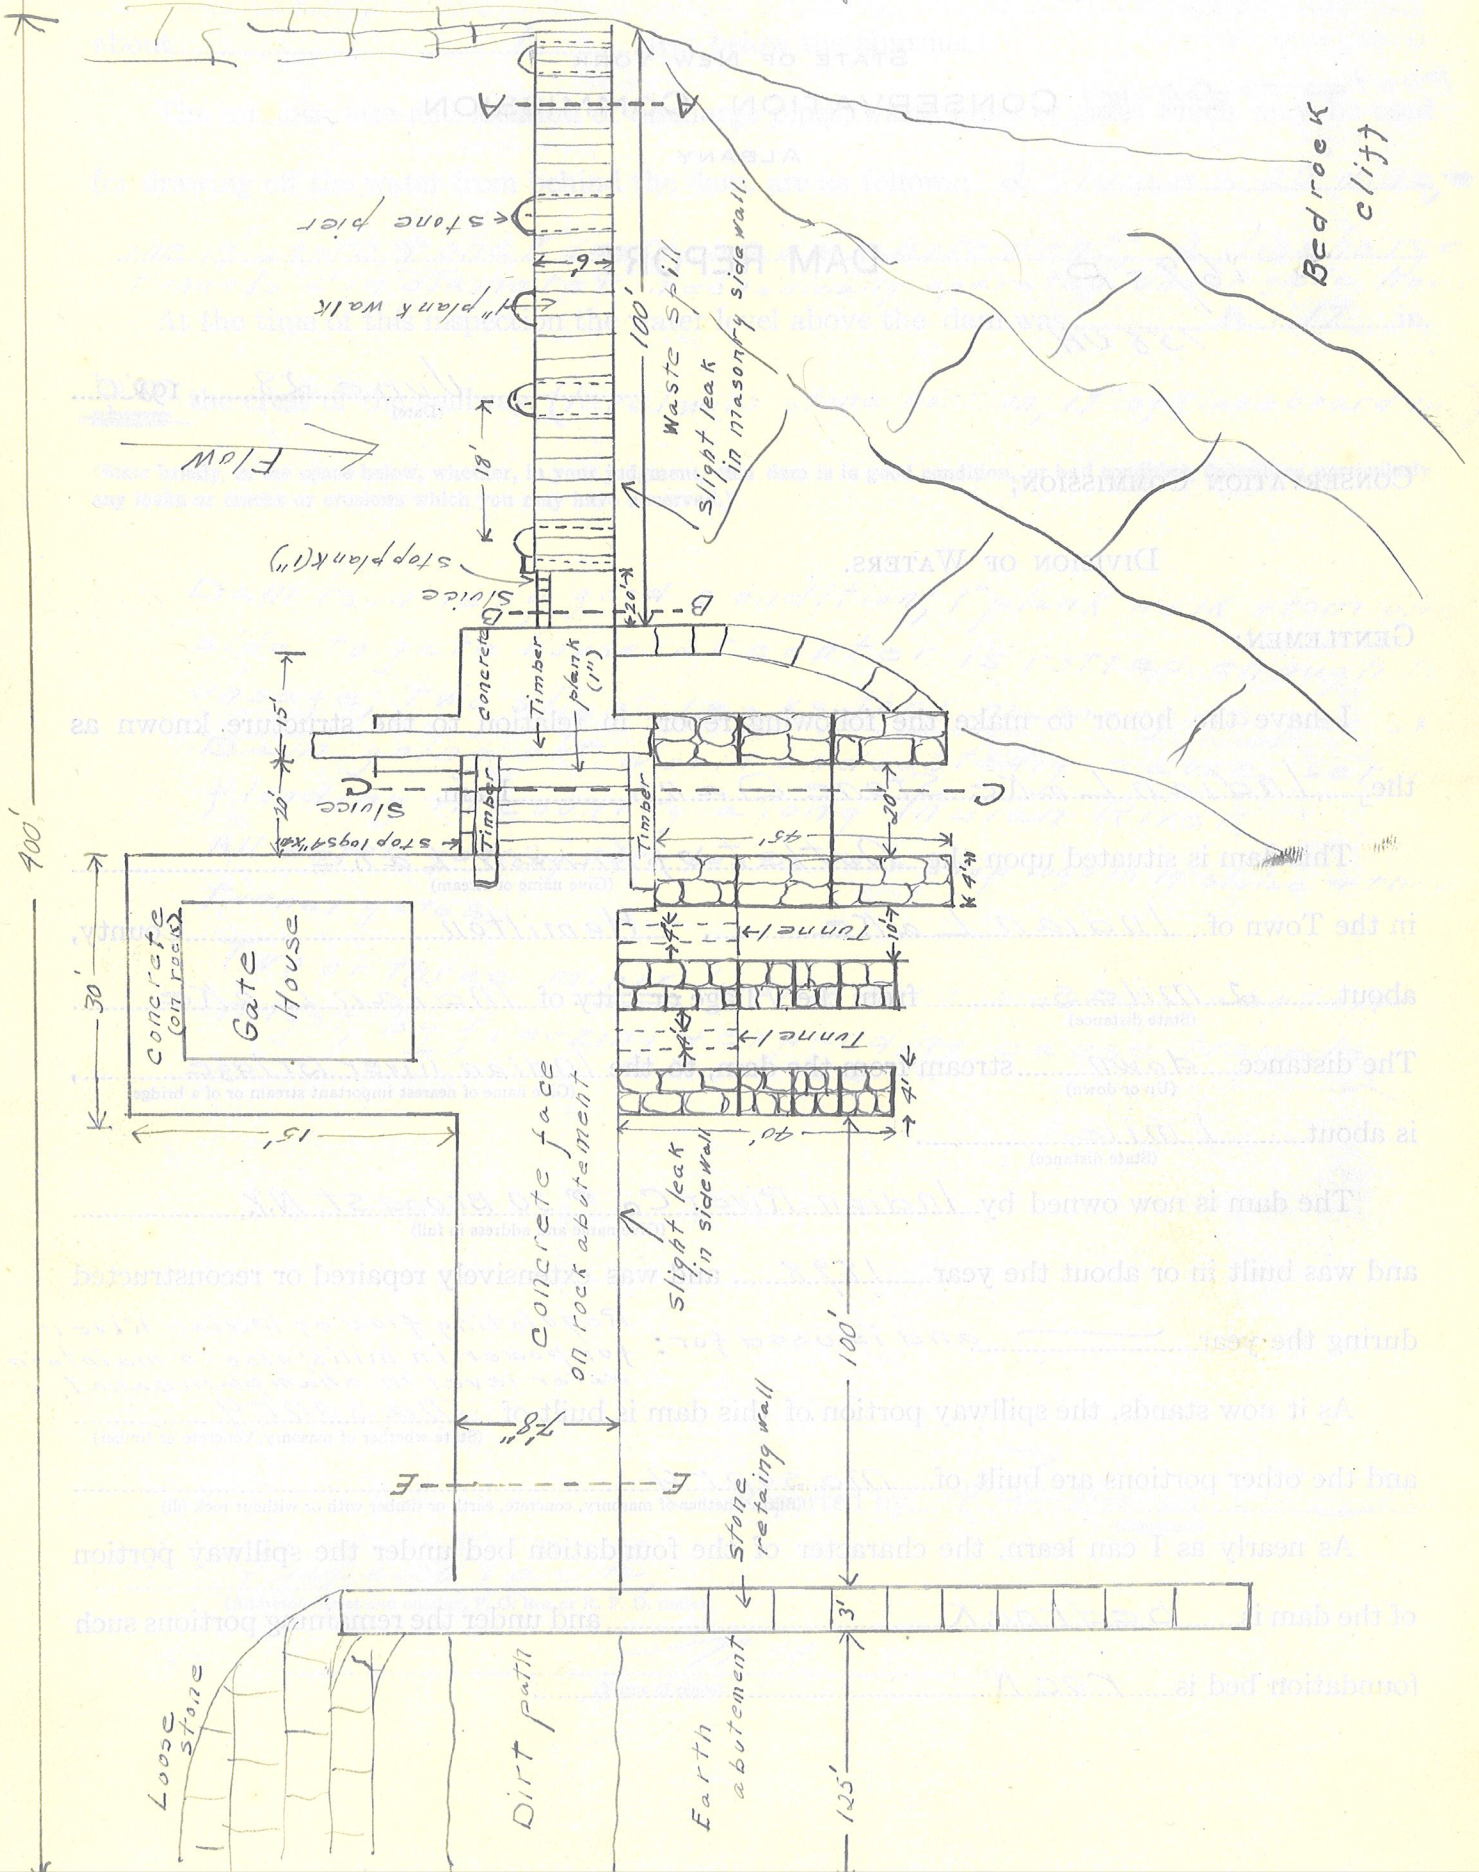
Dam is in very good condition; 1" plank walk from one side to gate house at center is rotted enough to be unsafe; two slight leaks thru masonry as per sketch. Dam going out would undoubtedly cause serious flooding in country along Indian River. All water getting thru leaks thru stop logs in 19' sluice & thru tunnel gates.

Two or three minor leaks thru masonry abutment might, by freezing & expanding cause trouble.

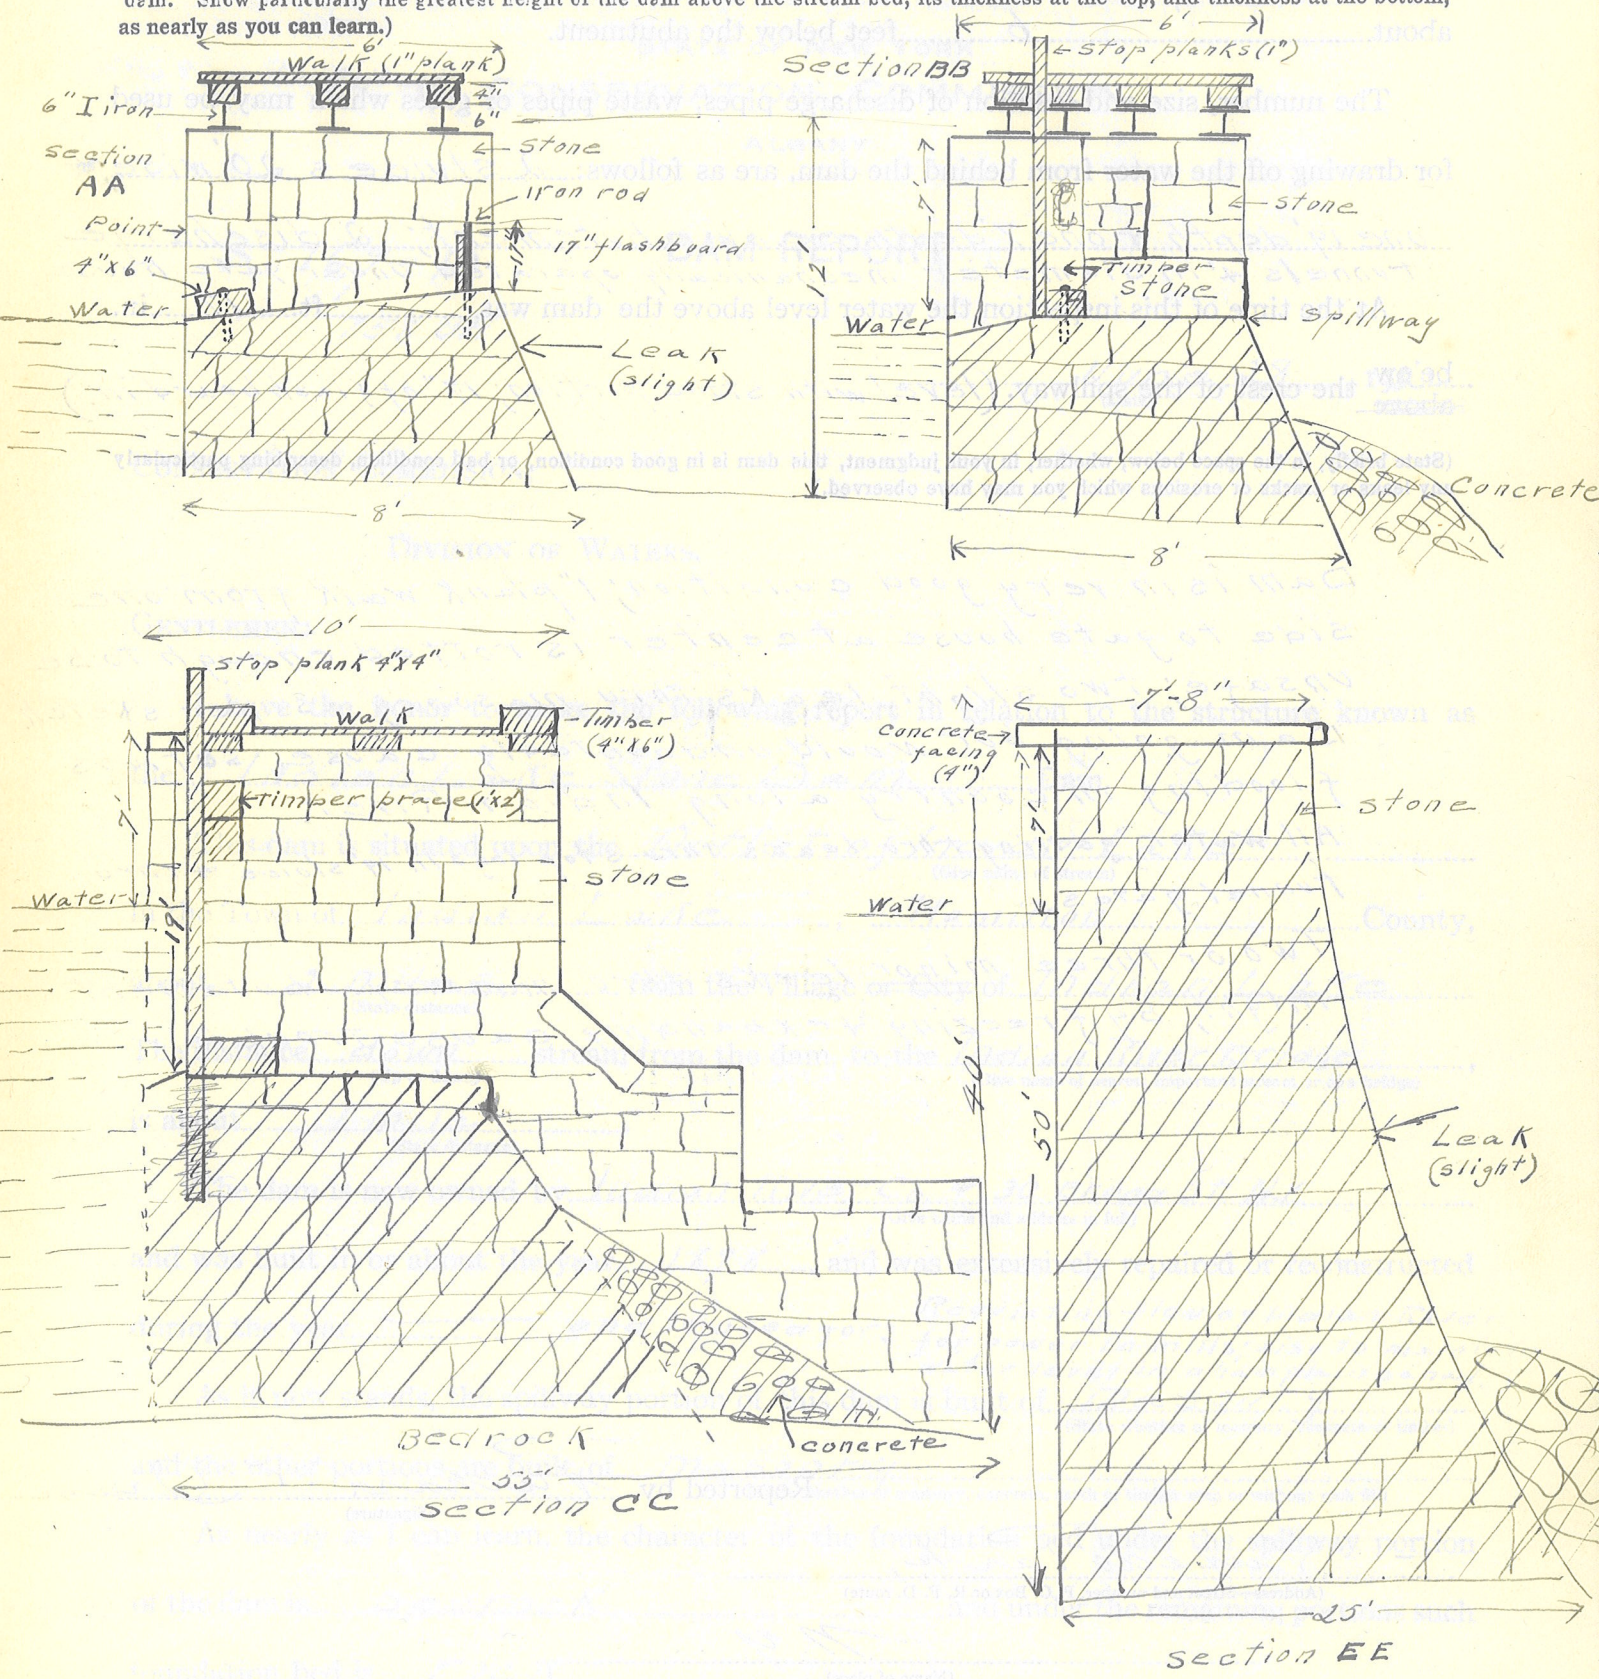
The total length of this dam is 400 feet. The spillway or waste-weir portion, is about 110 feet long, and the crest of the spillway is about 6 feet below the abutment.
