Re: Rainbow Lake Dam
DEC Dam ID#: 186-0849
Town of Indian Lake, Hamilton County
Class C – High Hazard Dam
Condition Rating: “Unsound – More Analysis needed”

2nd NOTICE OF VIOLATION

Visual Observations

DAM NAME Rainbow Lake Dam
STATE ID 186-0849 SECTION A HAZARD CODE C
COUNTY Hamilton INSPECTION DATE 8/31/2018
NEAREST DS CITY/TOWN Indian Lake INSPECTOR(S) CMS/JZD
OWNER'S NAME JASON ROBERTS DEVELOPMENT CORP.
DOWNSTREAM HAZARD High TOWNSHIP Town of Indian Lake

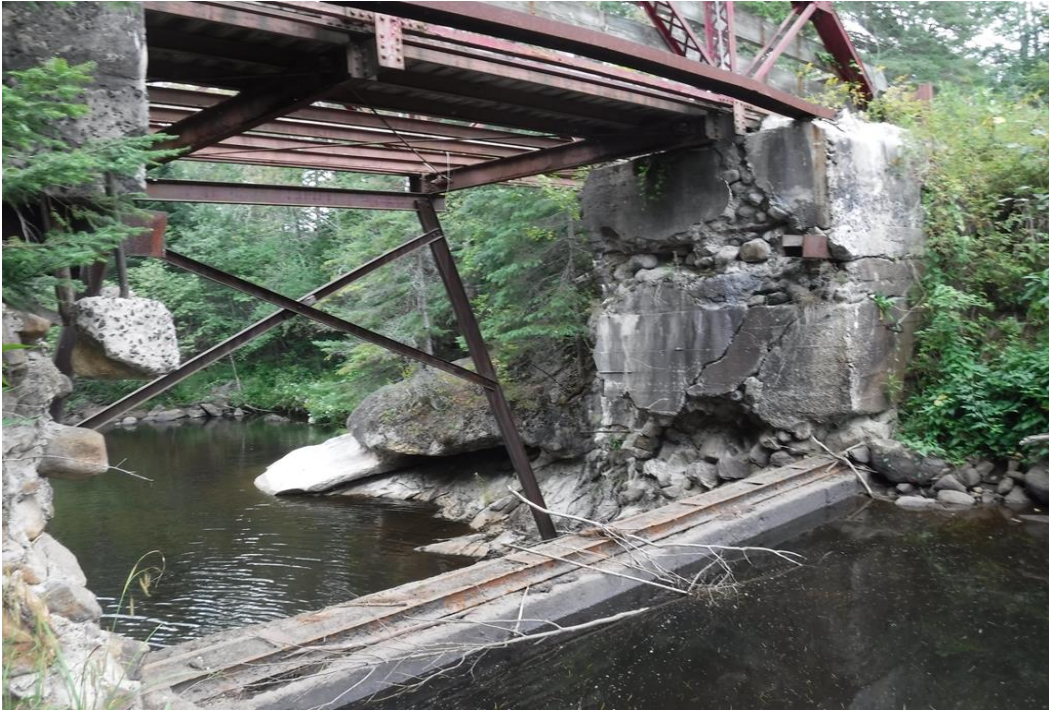
Photo 1 Dam ID# 186-0849 Rainbow Lake Dam 08/31/2018
Spillway looking downstream

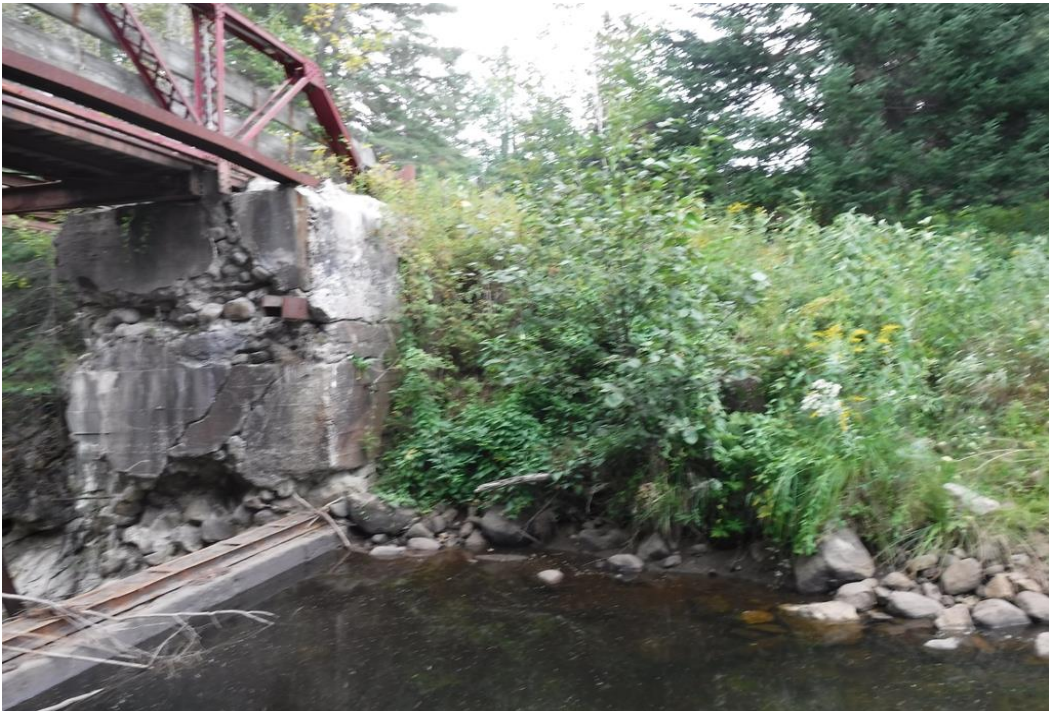
–Trees and brush on the left. Brush and tall weeds on the right.

Photo 2 Dam ID# 186-0849 Rainbow Lake Dam 08/31/2018
Right concrete wall and right upstream embankment

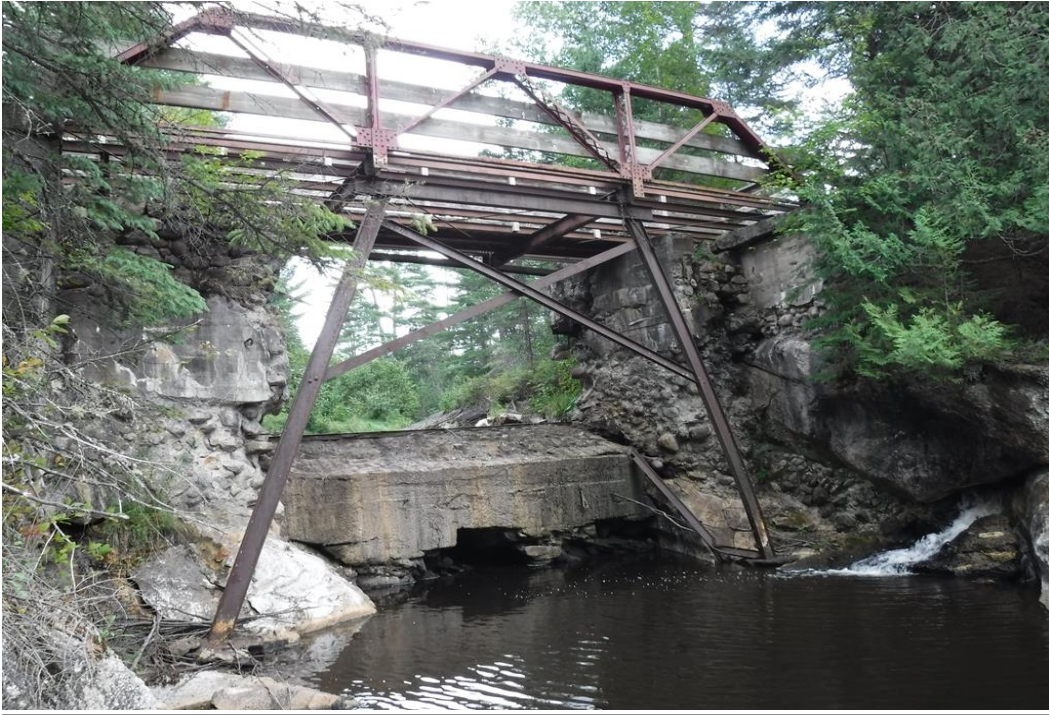
–Cut I-beams. Minor debris on spillway crest. Uneven apron. Voids. Exposed rebar. Trees growing from concrete. Vegetative growth.

Photo 3 Dam ID# 186-0849 Rainbow Lake Dam 08/31/2018
Downstream view of the spillway

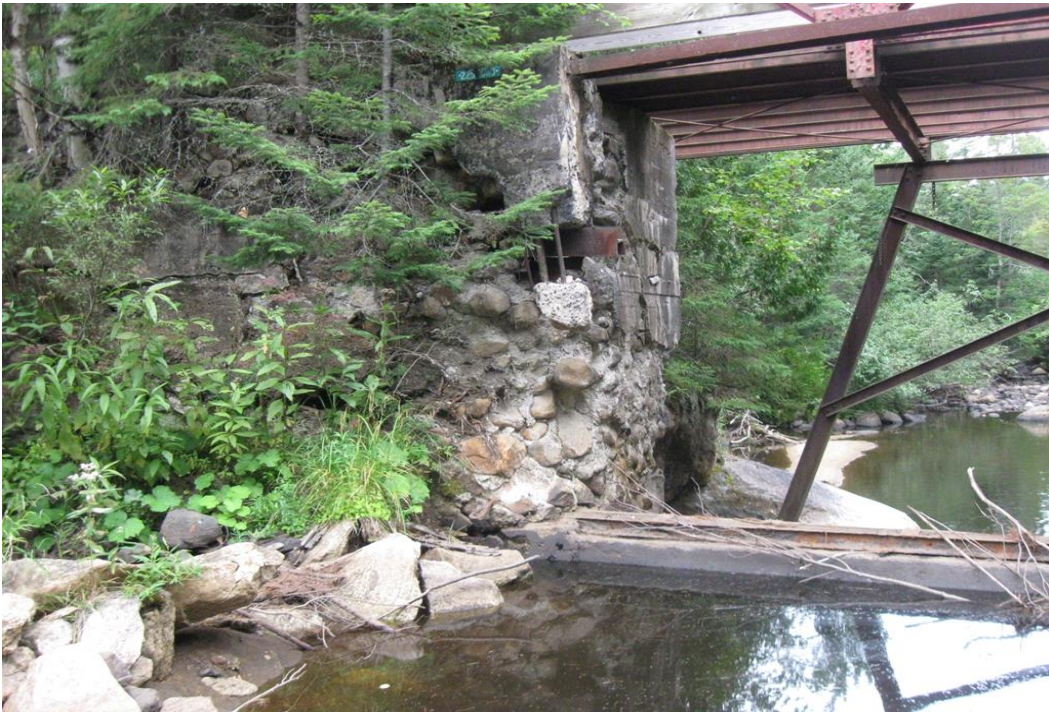
Photo 4 Dam ID# 186-0849 Rainbow Lake Dam 08/31/2018
Left concrete wall

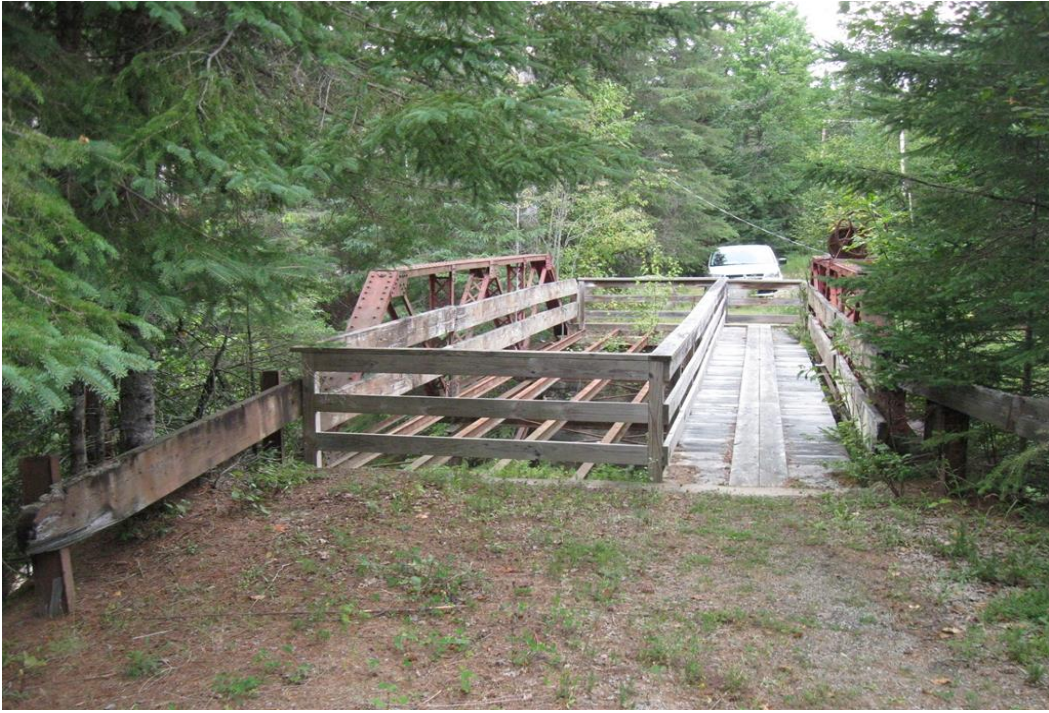
Photo 5 Dam ID# 186-0849 Rainbow Lake Dam 08/31/2018
Top of the dam as observed from the left abutment

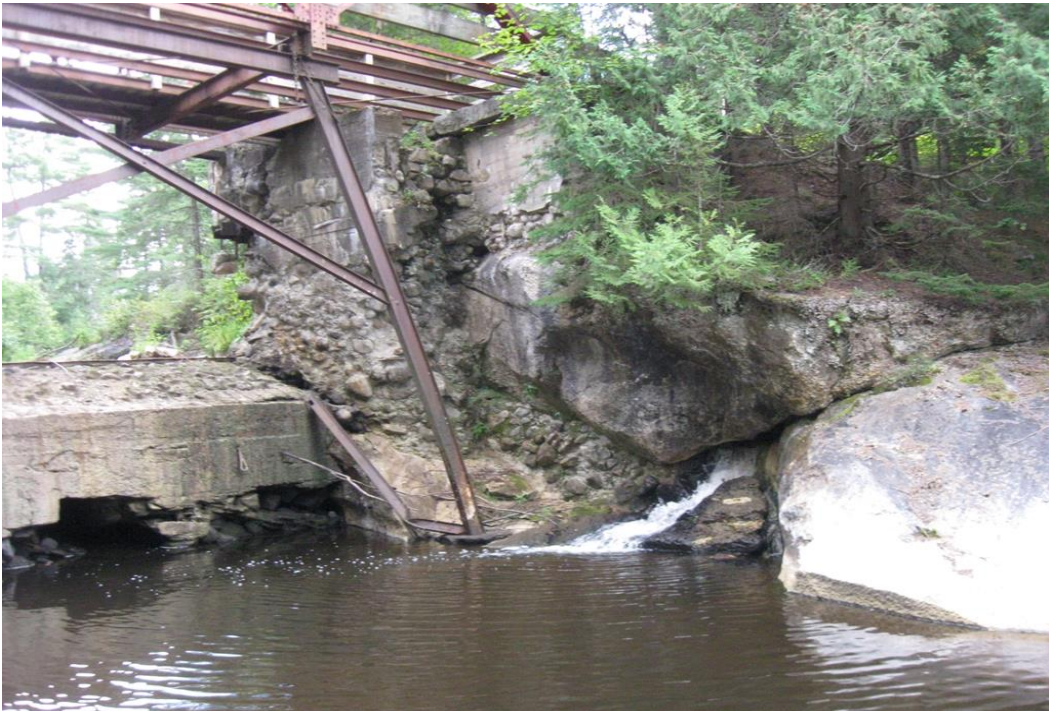
–Trees and brush. Leakage on the left side. Seepage on the right side.

Photo 6 Dam ID# 186-0849 Rainbow Lake Dam 08/31/2018
Left downstream embankment
