# INDIAN LAKE DAM REHABILITATION PROJECT

Town of Indian Lake, New York  
Hamilton County

**Hudson River -  
Black River  
Regulating District**

**BERGMANN**

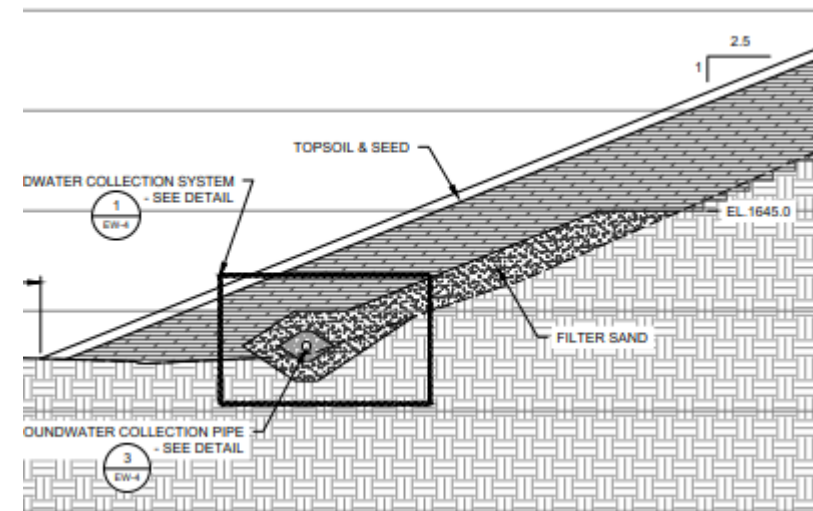
# EMBANKMENT STABILITY IMPROVEMENTS

## RAISING & FLATTENING EMBANKMENT, RETAINING WALL RETROFIT

- Must pass the Spillway Design Flood (SDF) without overtopping
- SDF peak water elevation EL. 1660.3 (1/2 PMF)
- Existing - The lowest point on the existing embankment is 1659.6 (0.7 feet below the SDF).
- Proposed 1-foot raise - Embankment crest will be raised to EL. 1661.0
  - SDF is passed without overtopping (proposed crest is 0.7 feet above the SDF elevation).
- Embankment improvements:
  - Raising the crest
  - Flattening the downstream slope
  - Granular drainage blanket & drain at toe
  - Armoring for Overtopping Protection (flood exceeding 1/2 PMF)
  - Improved Toe Drain System
  - Piezometer Extensions
  - Drivable Crest for Maintenance Access

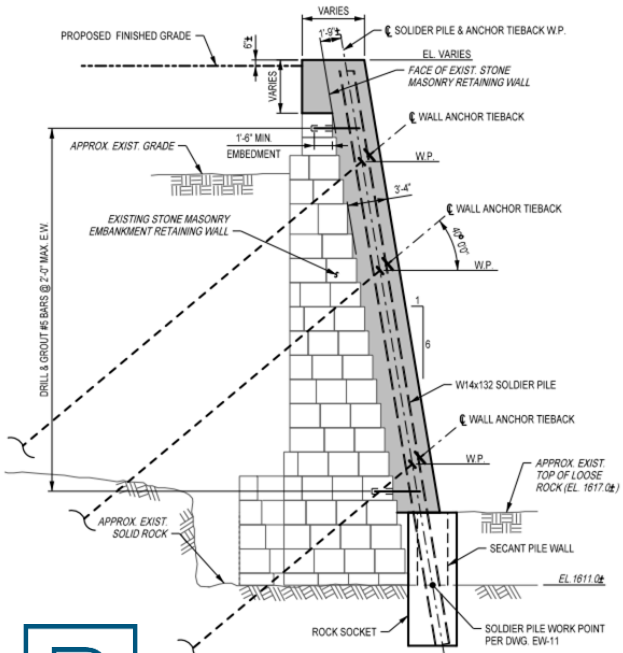
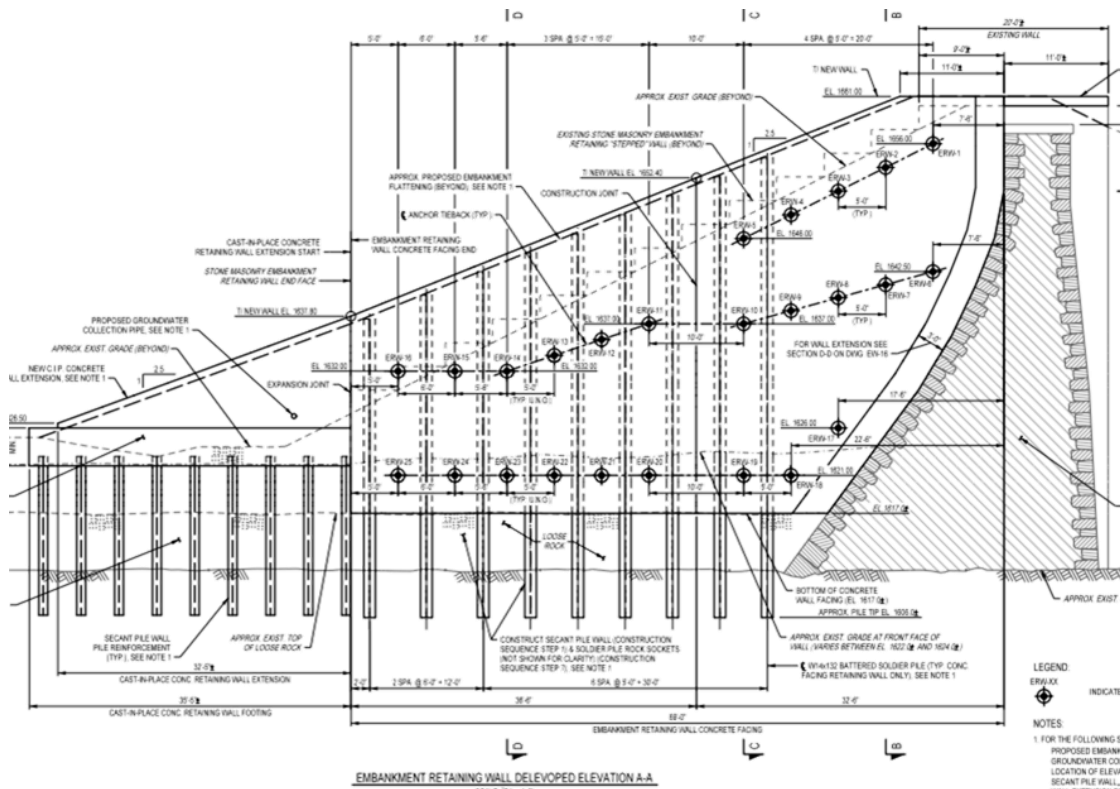
# EMBANKMENT STABILITY IMPROVEMENTS

## RAISING & FLATTENING EMBANKMENT, RETAINING WALL MODIFICATIONS

- Embankment Retaining Wall Improvements
  - Extending and Raising Wall to Support Embankment Raise
  - Concrete Facing
  - Secant Wall
  - Anchoring

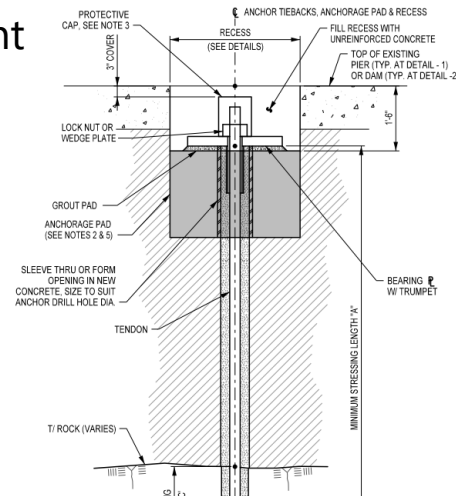
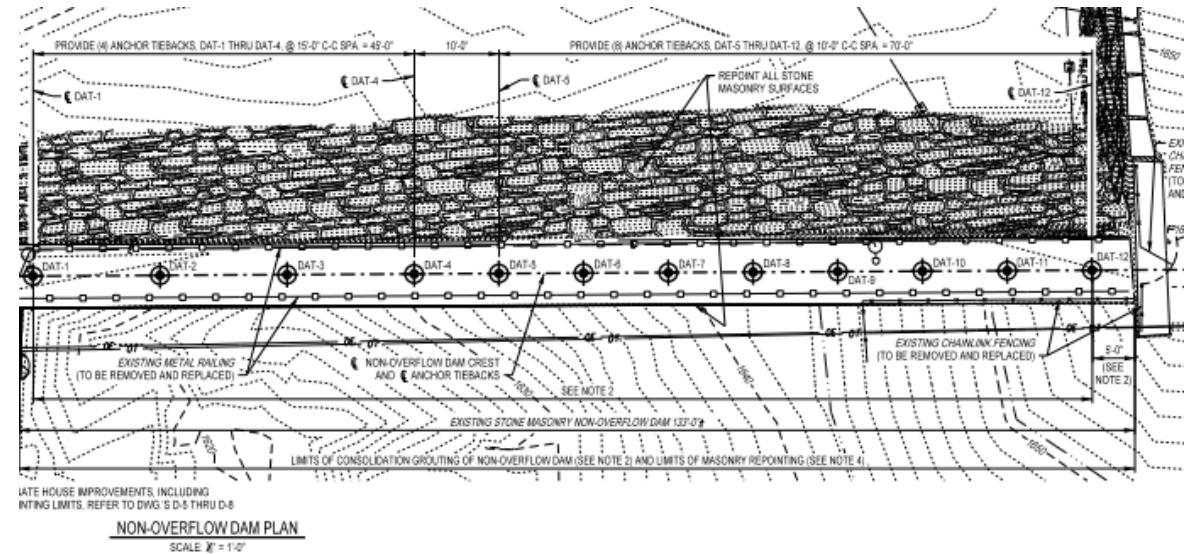
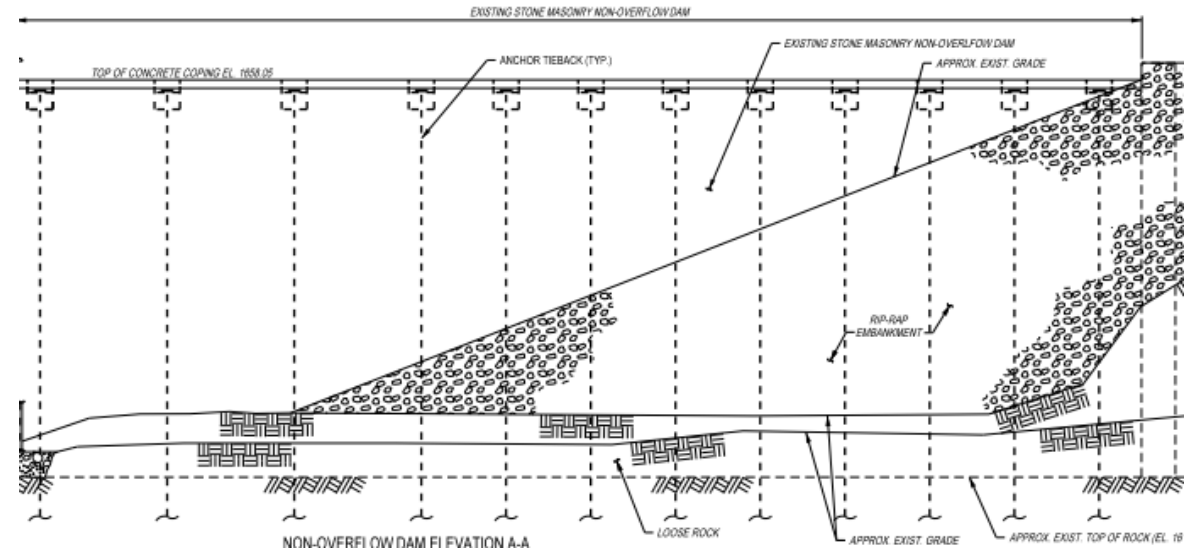
# STRUCTURAL STABILITY IMPROVEMENTS

## POST-TENSIONED ANCHORING & GROUTING

- Post-tensioned anchors (PTAs) required to meet required sliding & overturning stability criteria
  - Main concern in Ice and Flood cases
  - Anchor heads recessed into reinforced concrete anchorage pad with protective cap
- PTA Locations:
  - Embankment Retaining Wall
  - Non-Overflow
  - Spillway Right Abutment
  - Spillway Piers

<p><b>Section 10.7.2 presents requirements on the location of the resultant force from overturning analyses.</b></p>	<p>Structures will be anchored with post-tensioned rock anchors to meet requirement.</p>
<p><b>Section 10.7.4 presents minimum safety factors against sliding.</b></p>	<p>Structures will be anchored with post-tensioned rock anchors to meet required factors of safety.</p>
<p><b>Section 13.0 requires that all dams with toe drains have weirs on the downstream end of the drains. It also requires that the flow be measured and correlated with reservoir elevation.</b></p>	<p>The proposed embankment modifications include a toe drain that extends along the full length of the groin of the embankment and will include a monitoring weir to allow for flow measurement.</p>

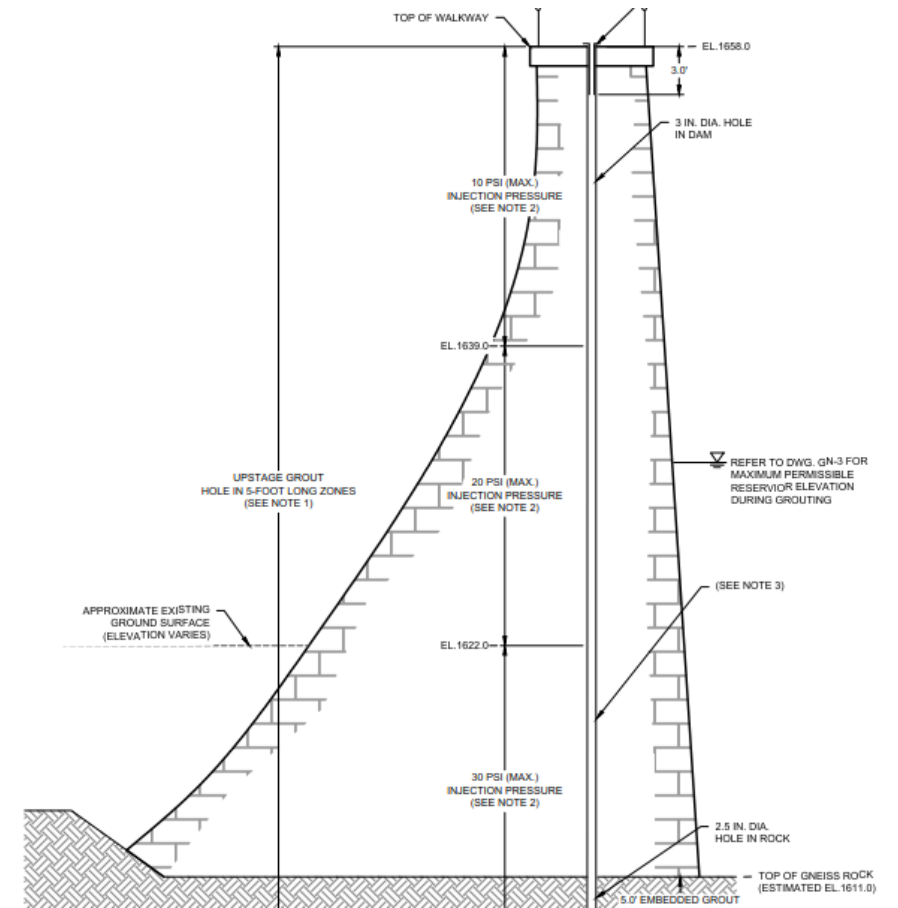
# LEAKAGE IMPROVEMENTS

## CONSOLIDATION GROUTING, MASONRY REPOINTING AND SEALING

- Leakage causing increased deterioration of the stone masonry & cyclopean concrete. Notable leakage locations:
  - Non-overflow
  - Embankment retaining wall
  - Spillway right end
- Consolidation Grouting
  - Use of cement grout with admixtures
  - Complete with reservoir lowered
  - Locations: Non-overflow, Spillway right end, Main logway

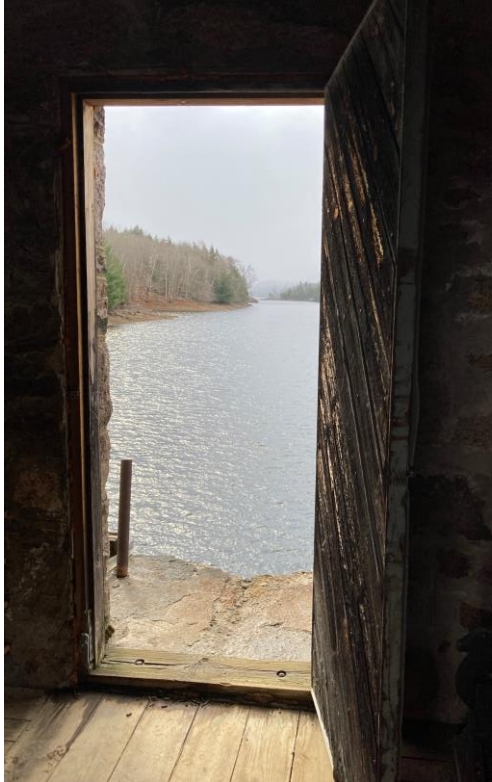
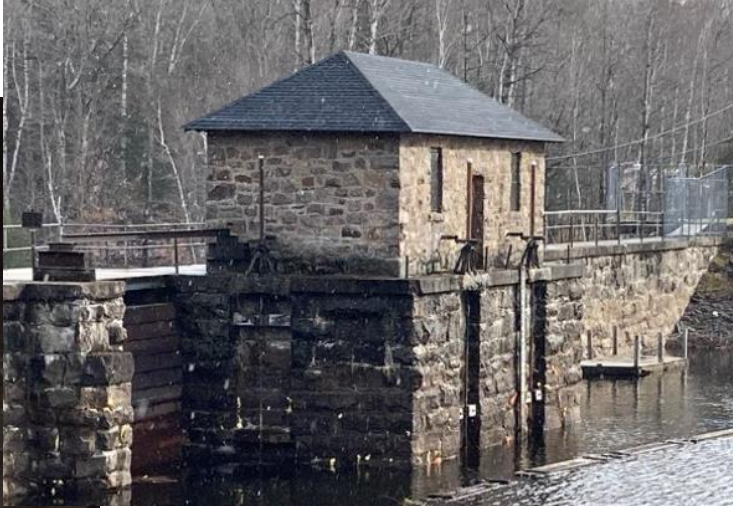
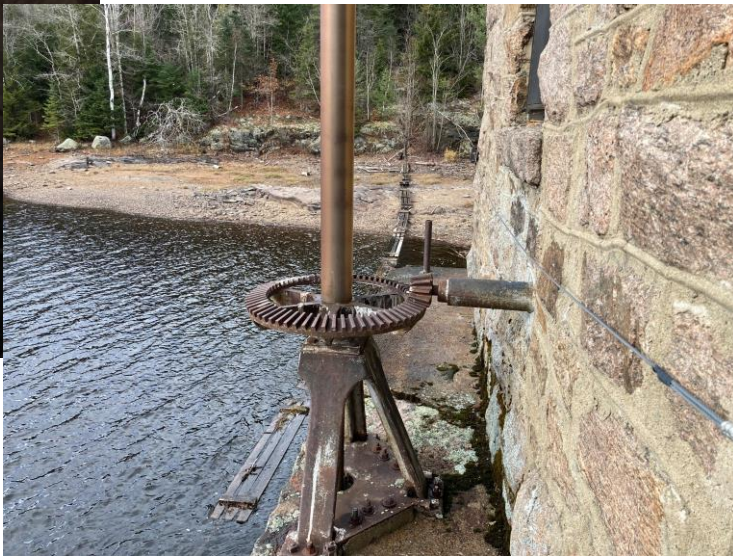
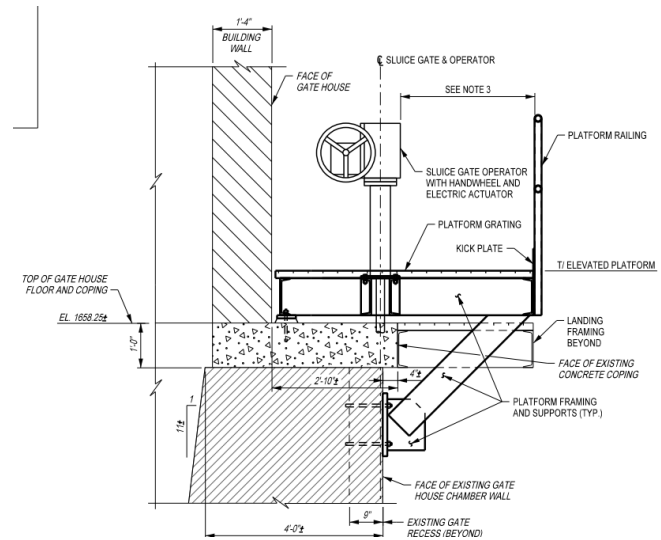
# OPERATIONS IMPROVEMENTS

## GATE REPLACEMENT AND NEW OPERATING PLATFORM

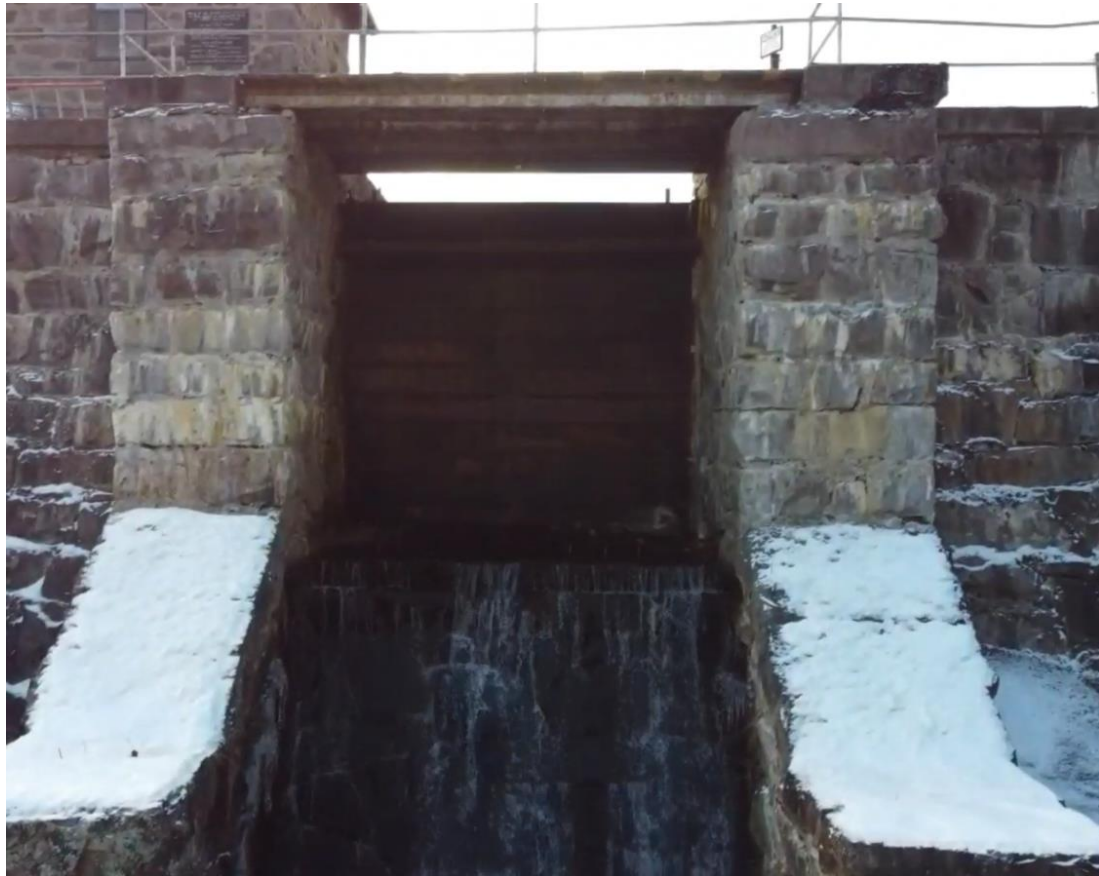
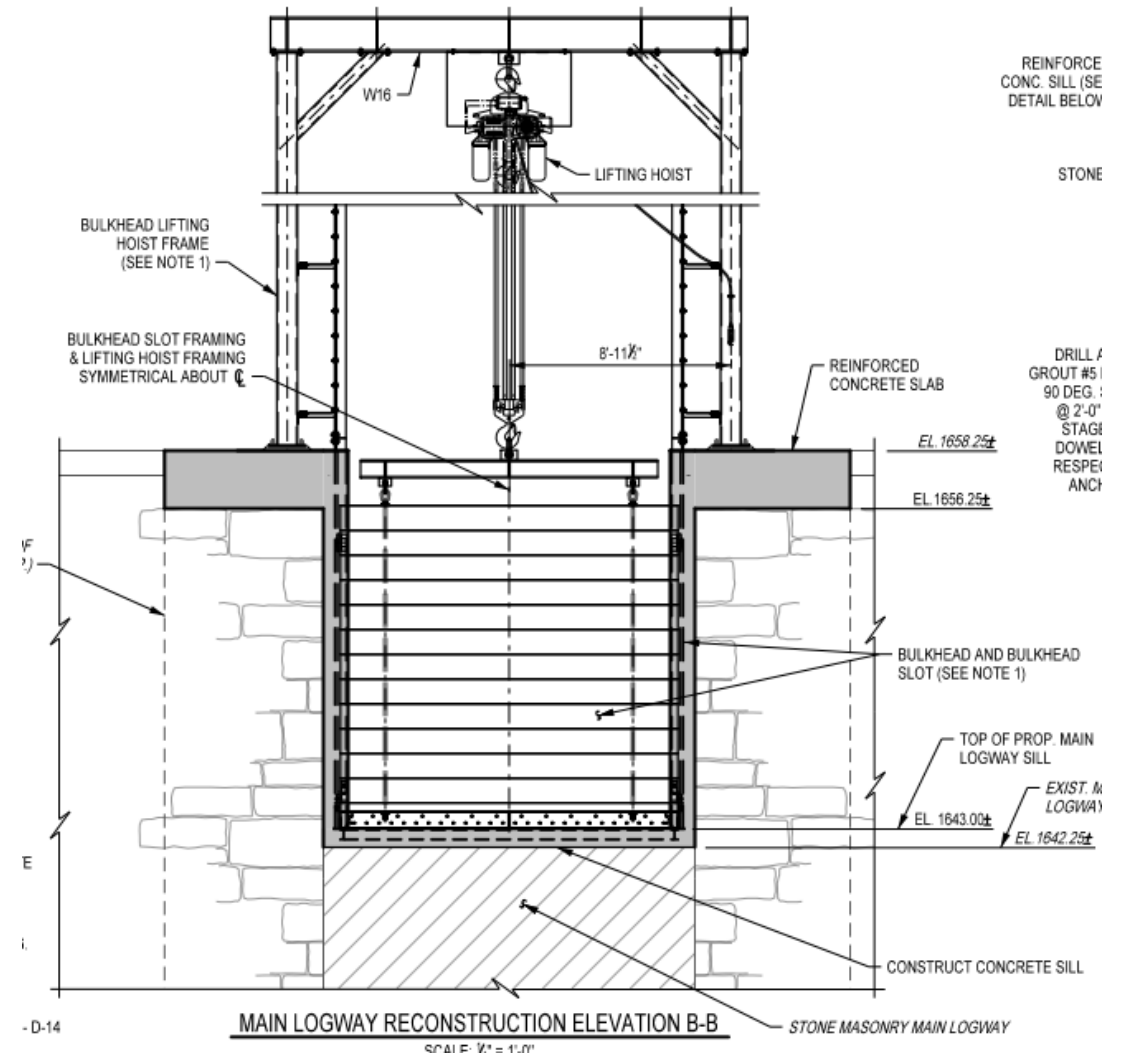
# MAIN LOGWAY BULKHEAD GATE

WATER CONTROL DURING CONSTRUCTION & FUTURE USE

Reservoir water release and water elevations anticipated to be consistent with normal reservoir operation throughout project construction.

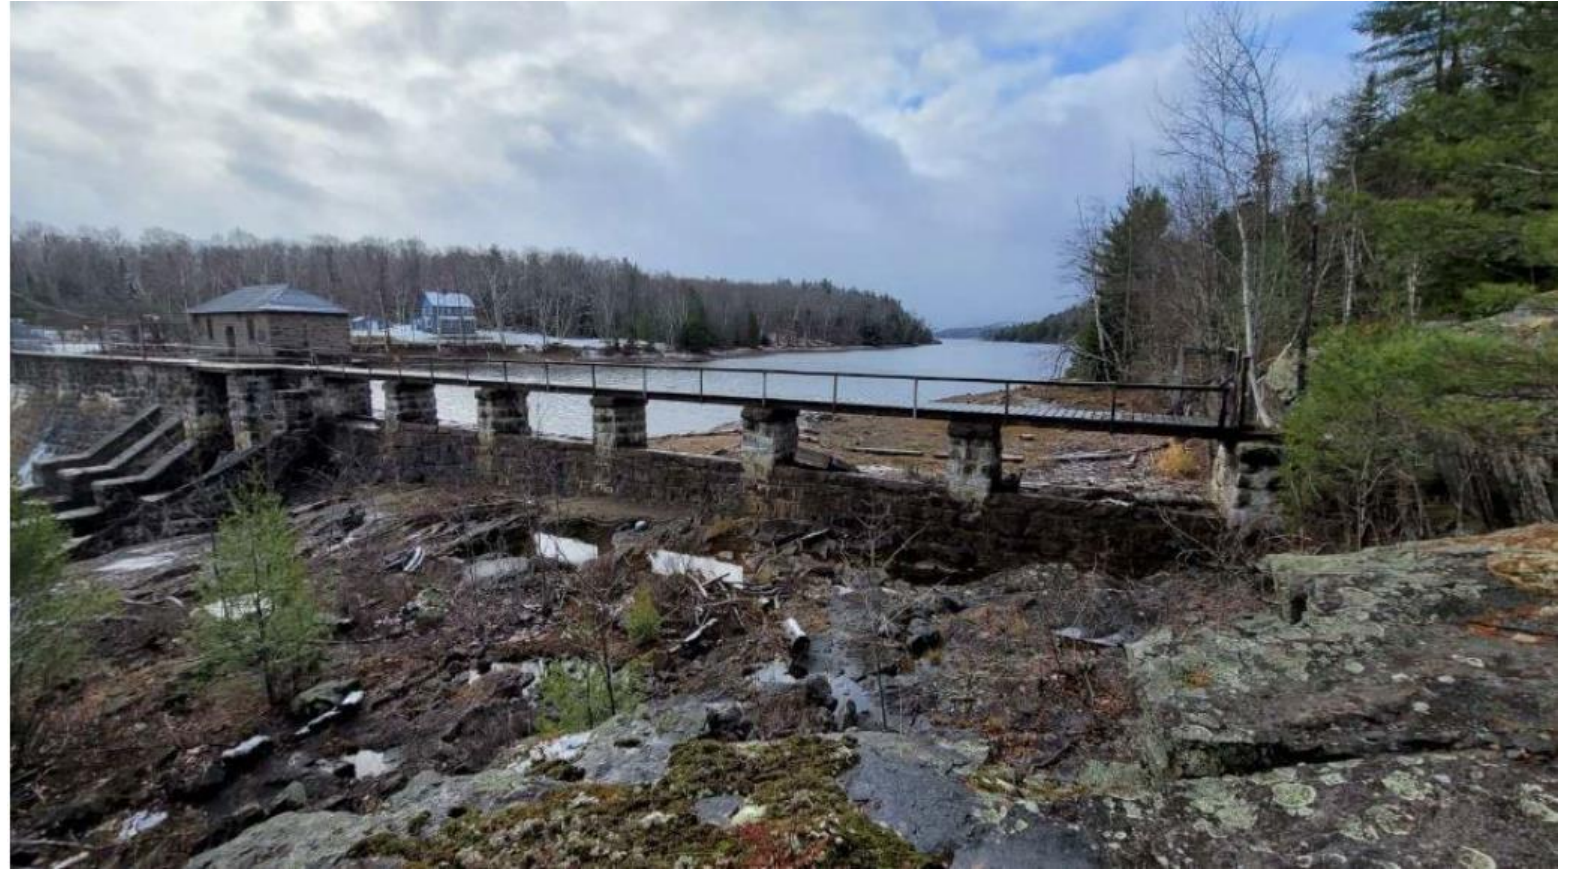
# SPILLWAY BRIDGE REPLACEMENT

- Existing bridge at end of service life (section loss, paint failure, surface rust, cracking timber deck)
- Installation of PTAs through spillway piers

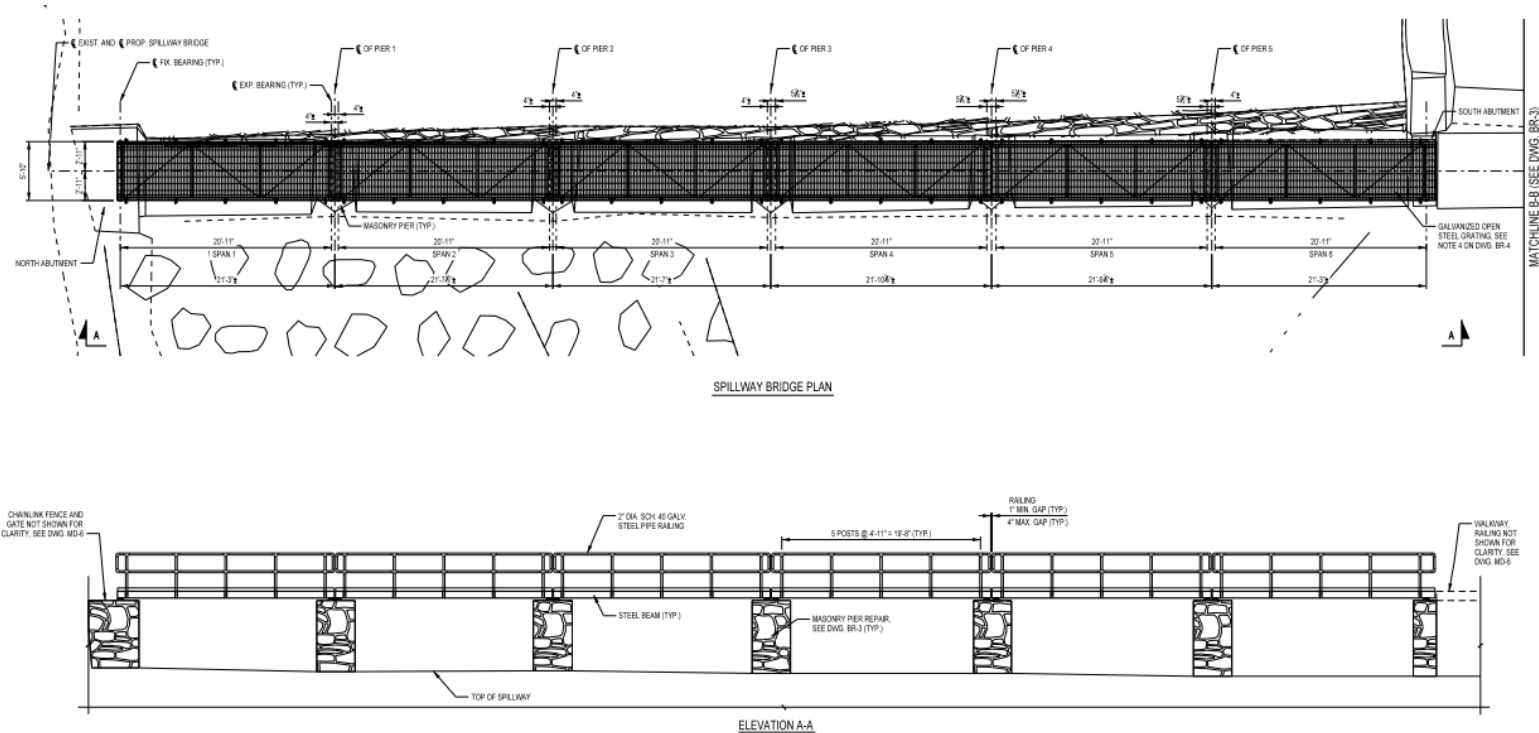
# SPILLWAY BRIDGE REPLACEMENT

- Proposed Replacement bridge:
  - Galvanized steel rolled shapes and grating
  - Railing on both sides of bridge for adequate fall protection
  - Less costly than repairing existing bridge
  - Low maintenance (galvanized, not painted)

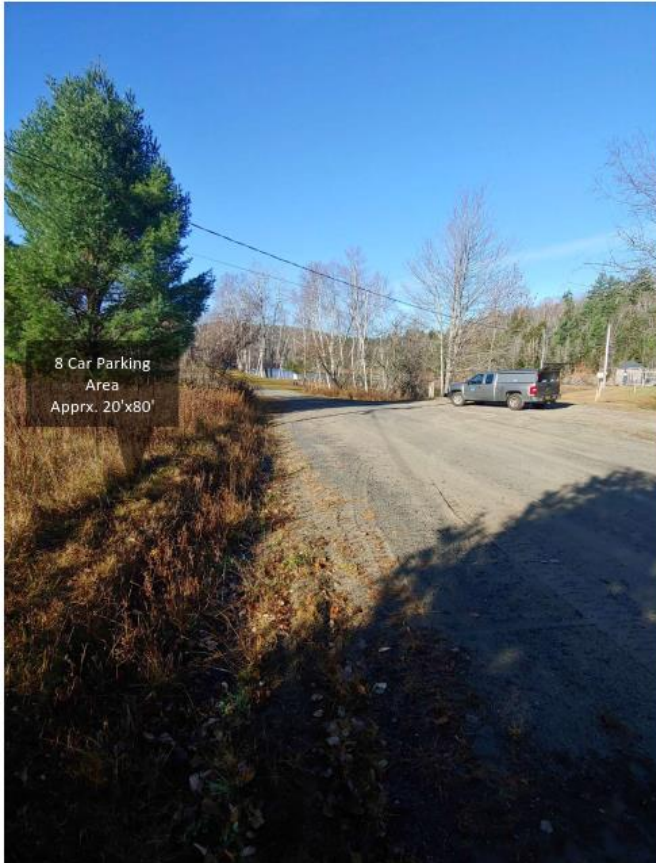
Indian Lake Dam Water Access Site – Proposed Parking Area

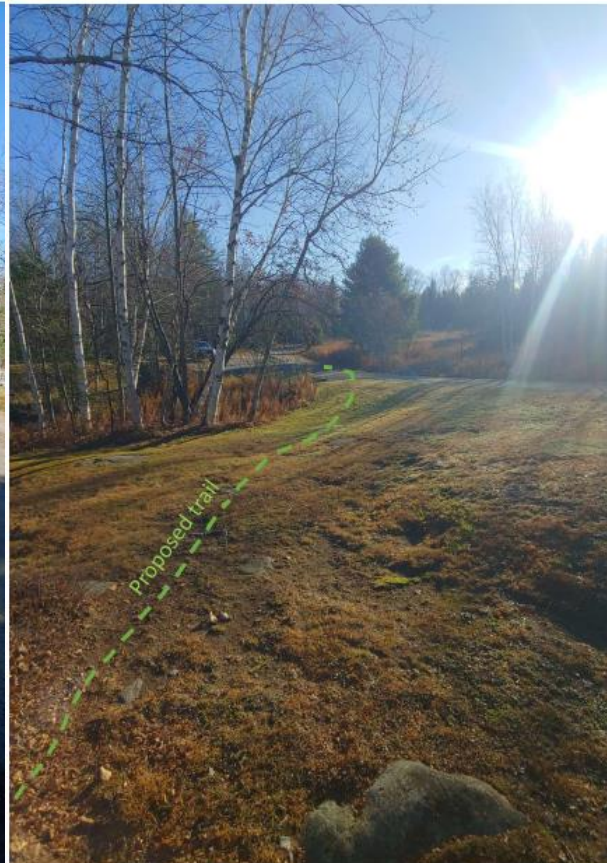
Indian Lake Dam Water Access Site – Lake Access Trail

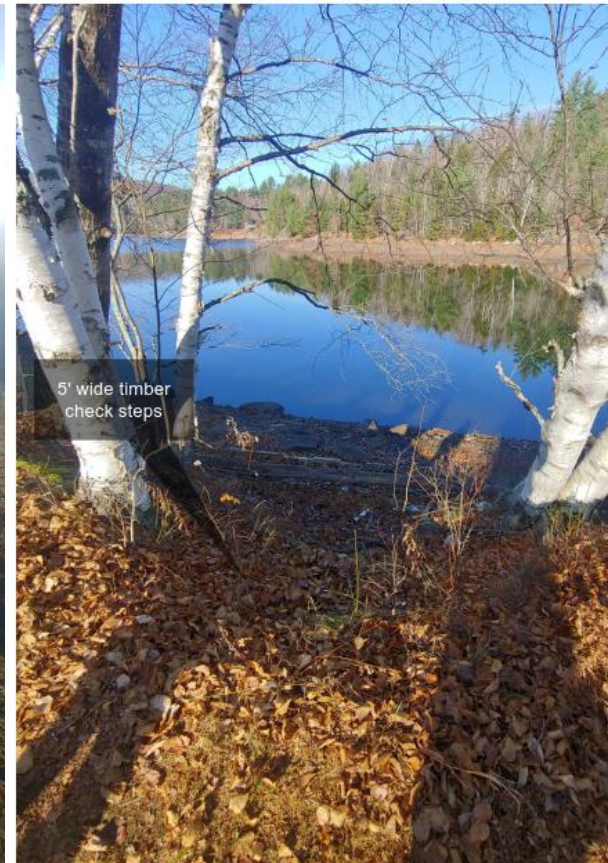
Indian Lake Dam Water Access Site – Launch Site

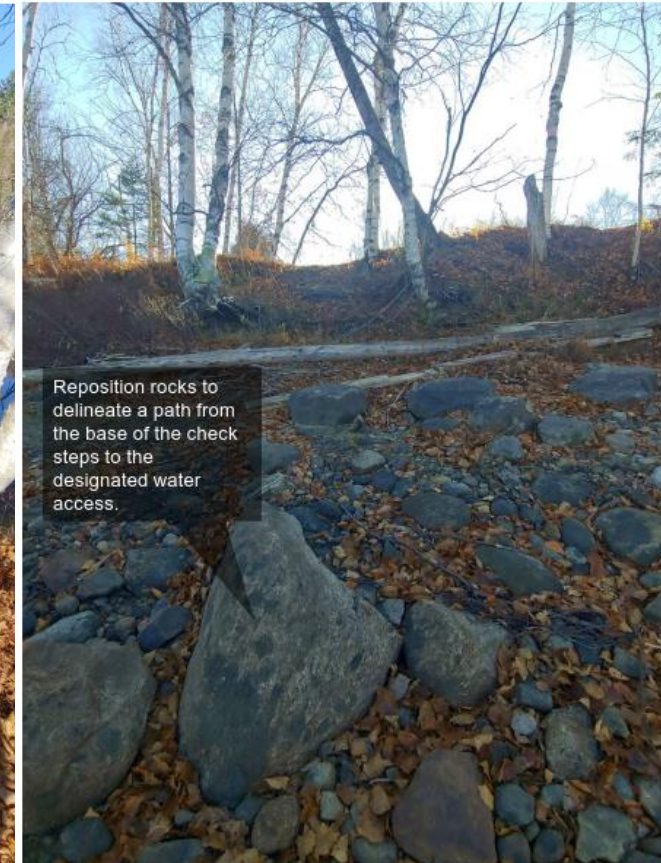
Indian Lake Dam Water Access Site - Shoreline Path
