# INDIAN LAKE DAM REHABILITATION PROJECT

Town of Indian Lake, New York  
Hamilton County

**Hudson River -  
Black River  
Regulating District**

# Overview

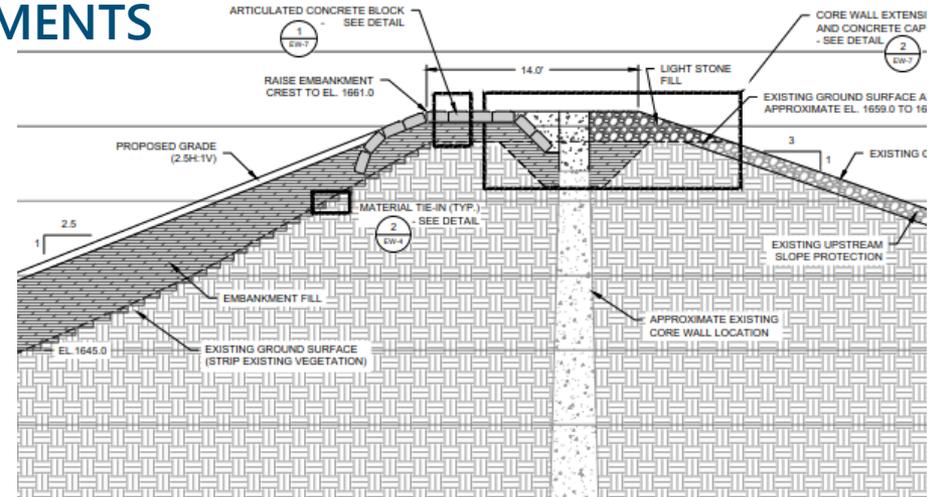
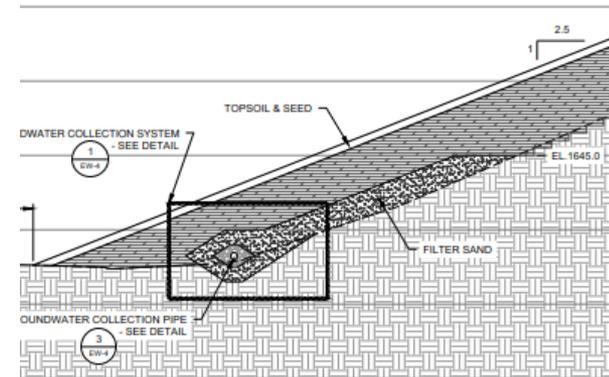
# EMBANKMENT STABILITY IMPROVEMENTS

## RAISING & FLATTENING EMBANKMENT, RETAINING WALL RETROFIT

- Must pass the Spillway Design Flood (SDF) without overtopping
- SDF peak water elevation EL. 1660.3 (1/2 PMF)
- Existing - The lowest point on the existing embankment is 1659.6 (0.7 feet below the SDF).
- Proposed 1-foot raise - Embankment crest will be raised to EL. 1661.0
  - SDF is passed without overtopping (proposed crest is 0.7 feet above the SDF elevation).
- Embankment improvements:
  - Raising the crest
  - Flattening the downstream slope
  - Granular drainage blanket & drain at toe
  - Armoring for Overtopping Protection (flood exceeding 1/2 PMF)
  - Improved Toe Drain System
  - Piezometer Extensions
  - Drivable Crest for Maintenance Access

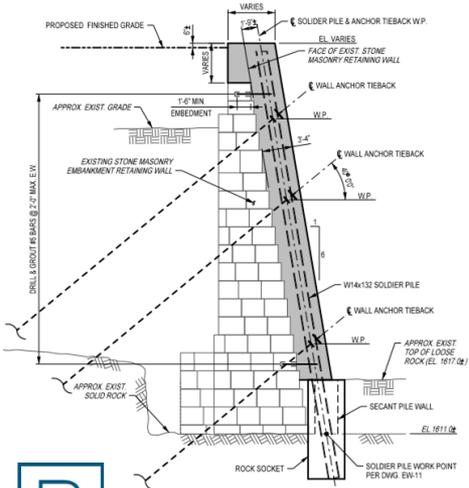
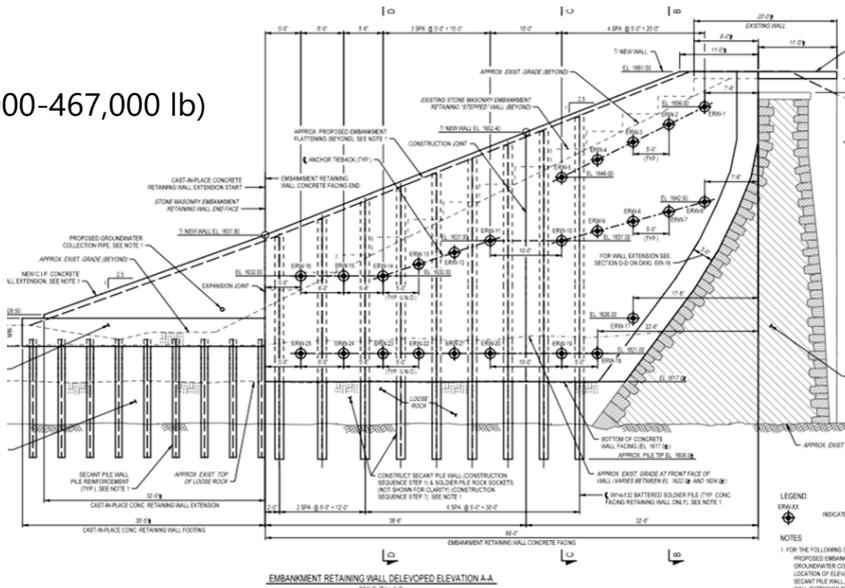
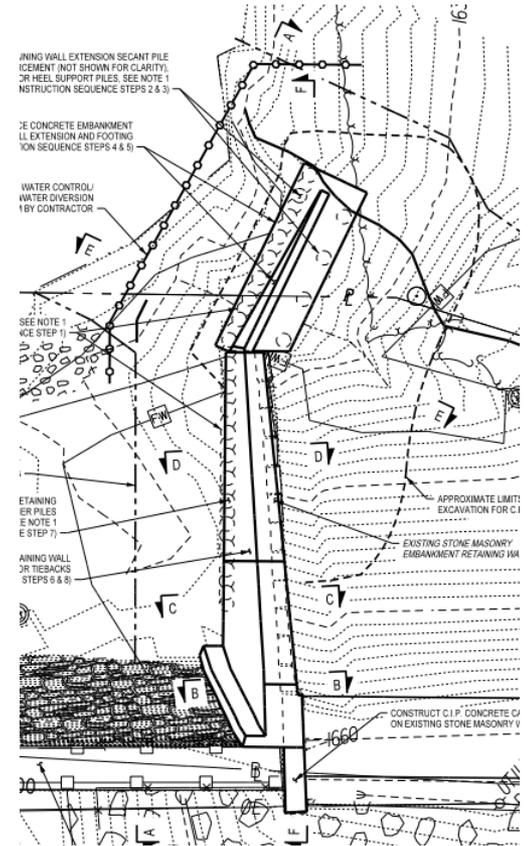
# EMBANKMENT STABILITY IMPROVEMENTS

## RAISING & FLATTENING EMBANKMENT, RETAINING WALL MODIFICATIONS

- Embankment Retaining Wall Improvements
  - Extending and Raising Wall to Support Embankment Raise
  - Concrete Facing
  - Secant Wall
  - Anchoring (142,000-467,000 lb)

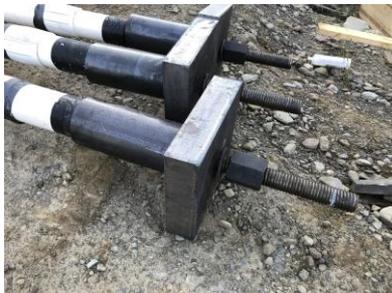
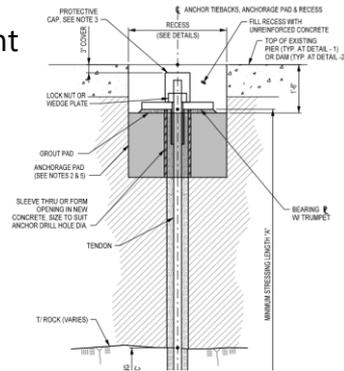
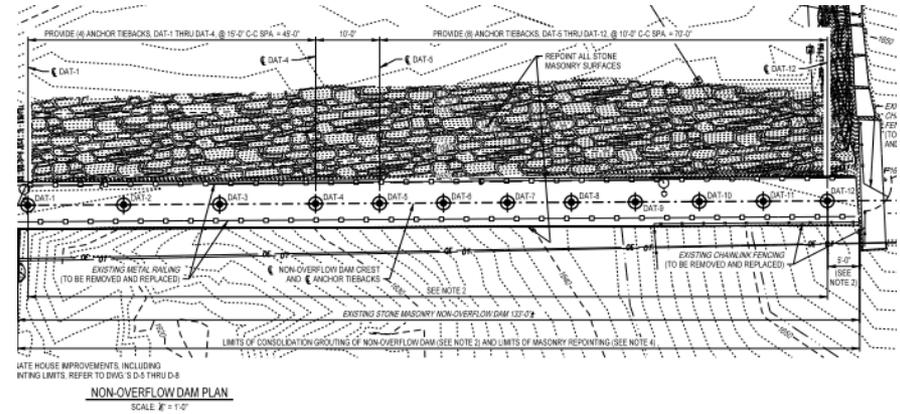
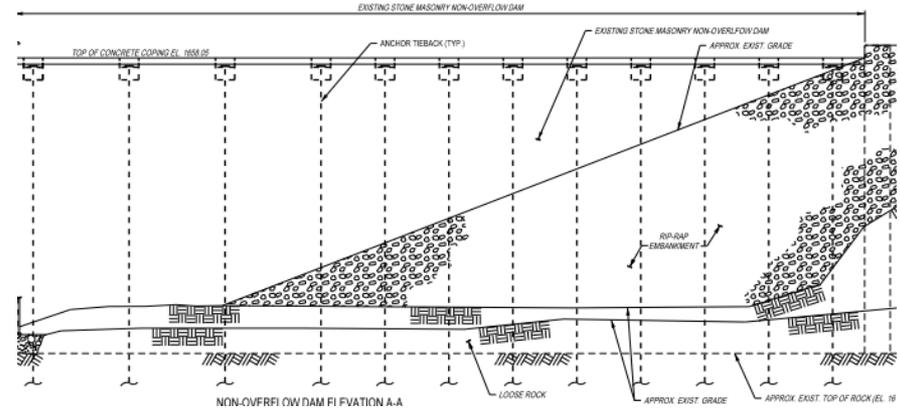
# STRUCTURAL STABILITY IMPROVEMENTS

## POST-TENSIONED ANCHORING & GROUTING

- Post-tensioned anchors (PTAs) required to meet required sliding & overturning stability criteria
  - Main concern in Ice and Flood cases
  - Anchor heads recessed into reinforced concrete anchorage pad with protective cap
  - Anchor forces range from 142,000-528,000 lb
- PTA Locations:
  - Embankment Retaining Wall
  - Non-Overflow
  - Spillway Right Abutment
  - Spillway Piers

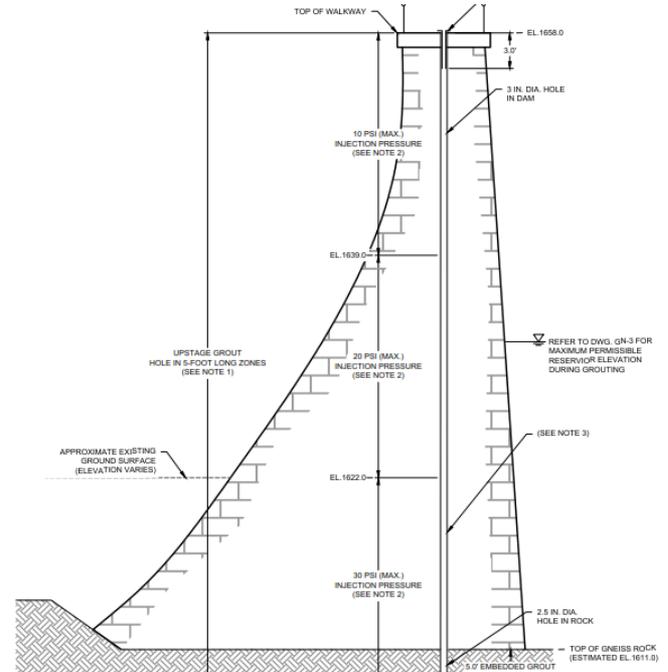
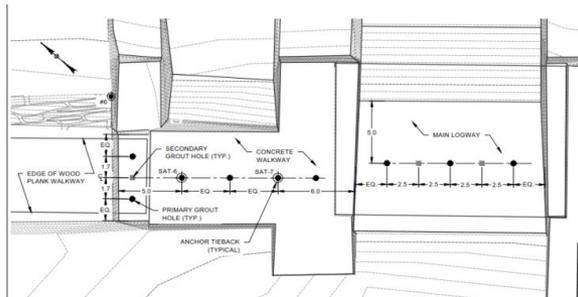
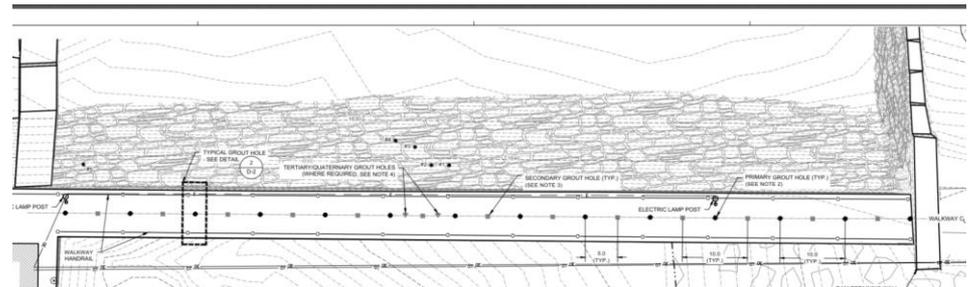
# LEAKAGE IMPROVEMENTS

CONSOLIDATION GROUTING, MASONRY REPOINTING AND SEALING

- Leakage causing increased deterioration of the stone masonry & cyclopean concrete. Notable leakage locations:
  - Non-overflow
  - Embankment retaining wall
  - Spillway right end
- Consolidation Grouting
  - Use of cement grout with admixtures
  - Complete with reservoir lowered
  - Locations: Non-overflow, Spillway right end, Main logway

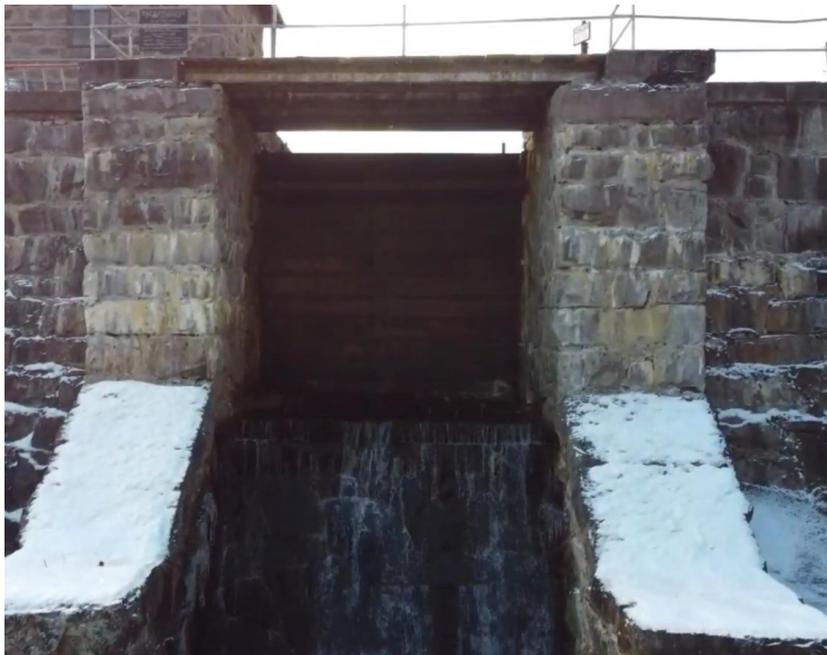
# MAIN LOGWAY BULKHEAD GATE

WATER CONTROL DURING CONSTRUCTION & FUTURE USE

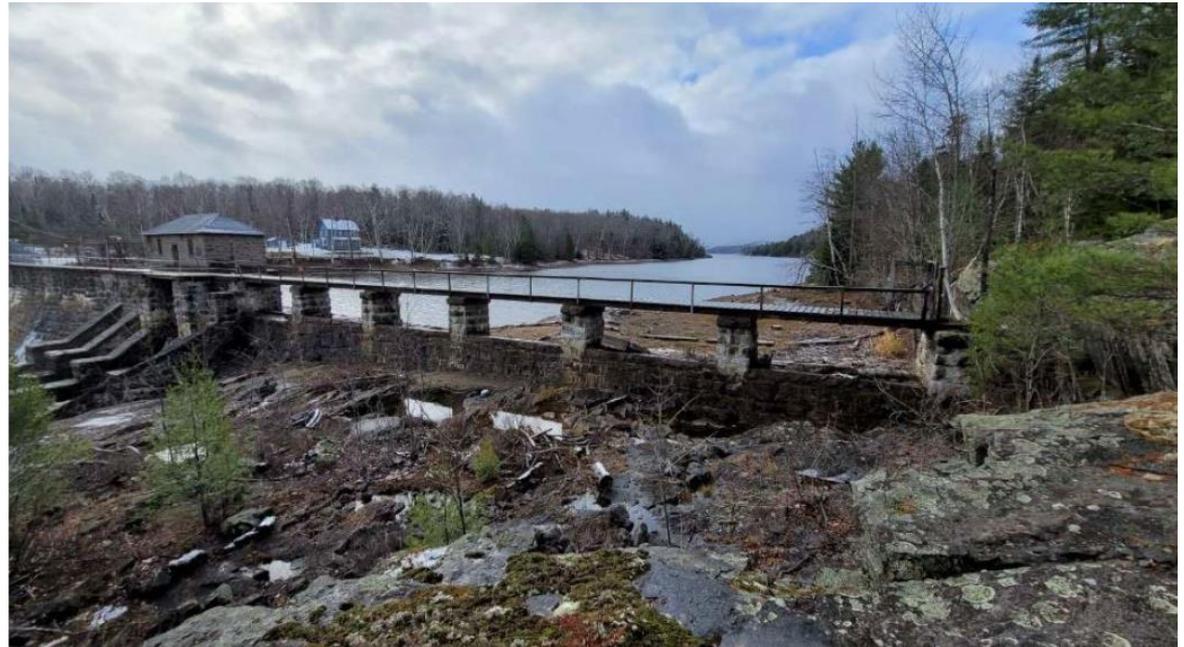
## SPILLWAY BRIDGE REPLACEMENT

- Existing bridge at end of service life (section loss, paint failure, surface rust, cracking timber deck)
- Installation of PTAs through spillway piers

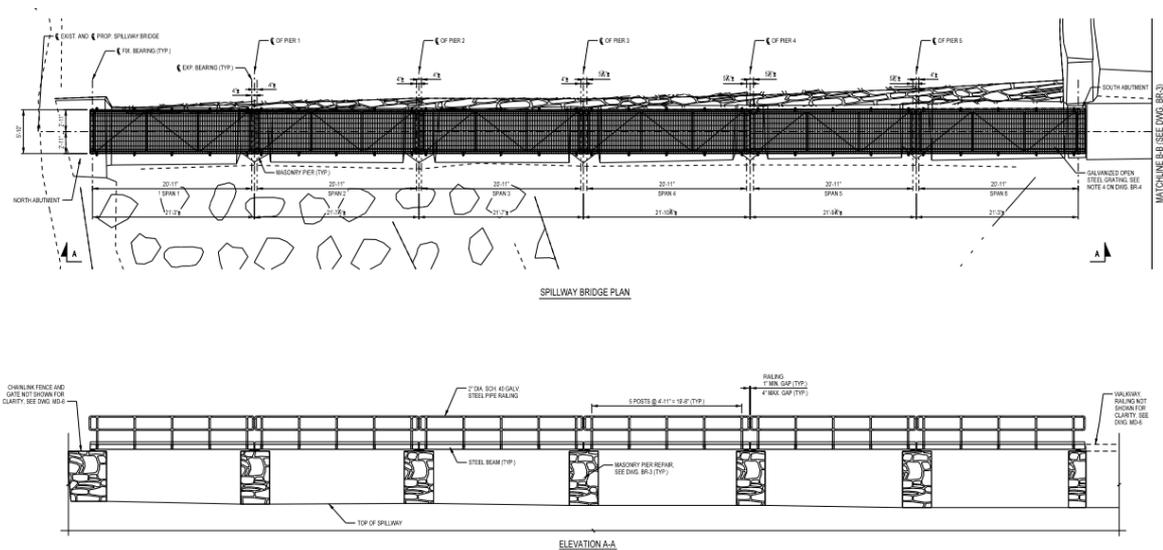
# SPILLWAY BRIDGE REPLACEMENT

- Proposed Replacement bridge:
  - Galvanized steel rolled shapes and grating
  - Railing on both sides of bridge for adequate fall protection
  - Less costly than repairing existing bridge
  - Low maintenance (galvanized, not painted)

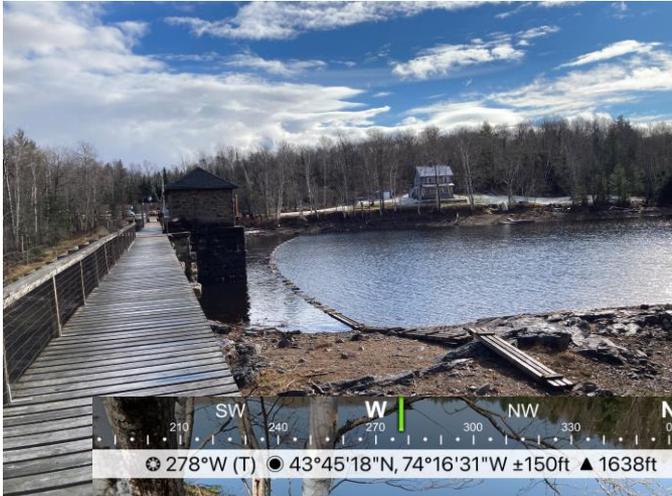
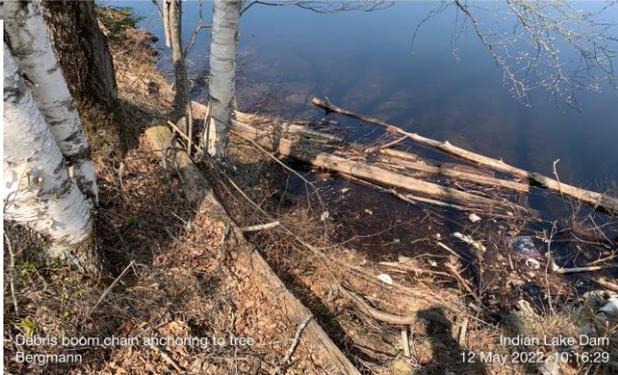
# DEBRIS BOOM REPLACEMENT

Debris boom chain anchoring to tree  
Bergmann

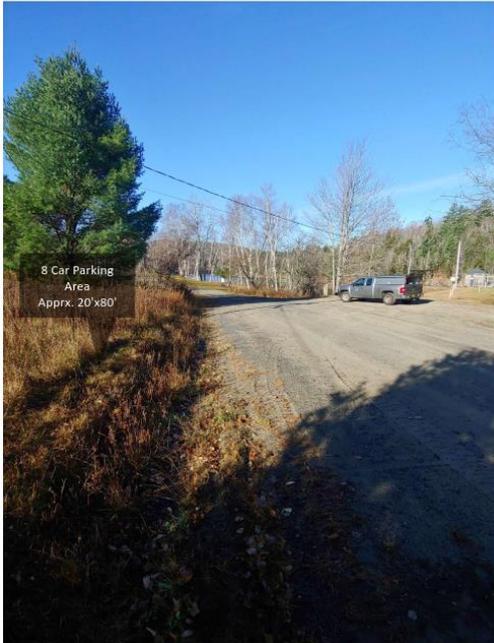
Indian Lake Dam Water Access Site – Proposed Parking Area

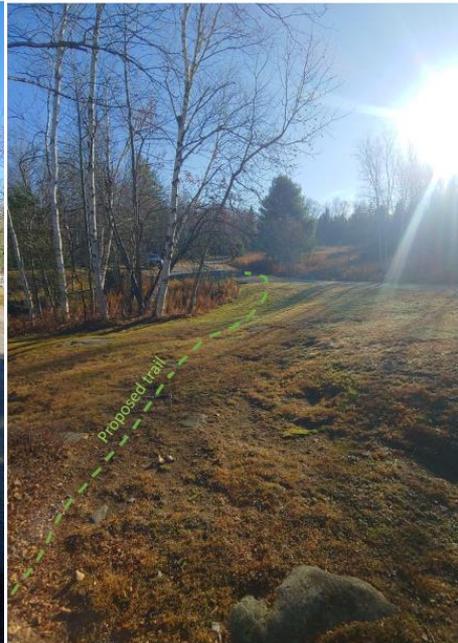
Indian Lake Dam Water Access Site – Lake Access Trail

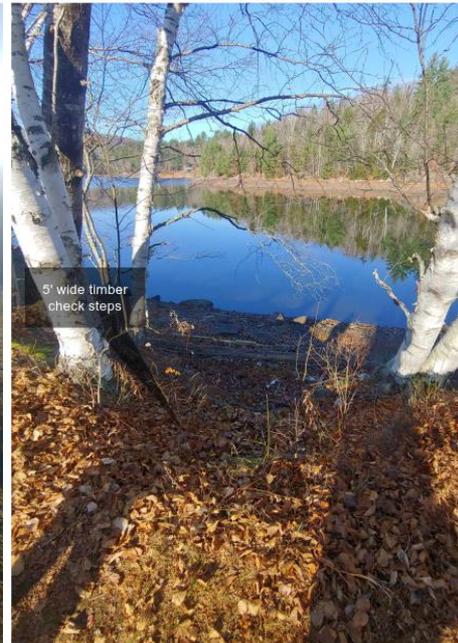
Indian Lake Dam Water Access Site – Launch Site

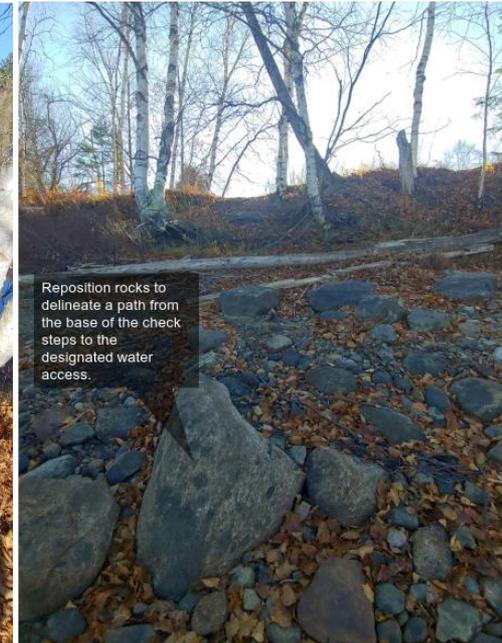
Indian Lake Dam Water Access Site - Shoreline Path

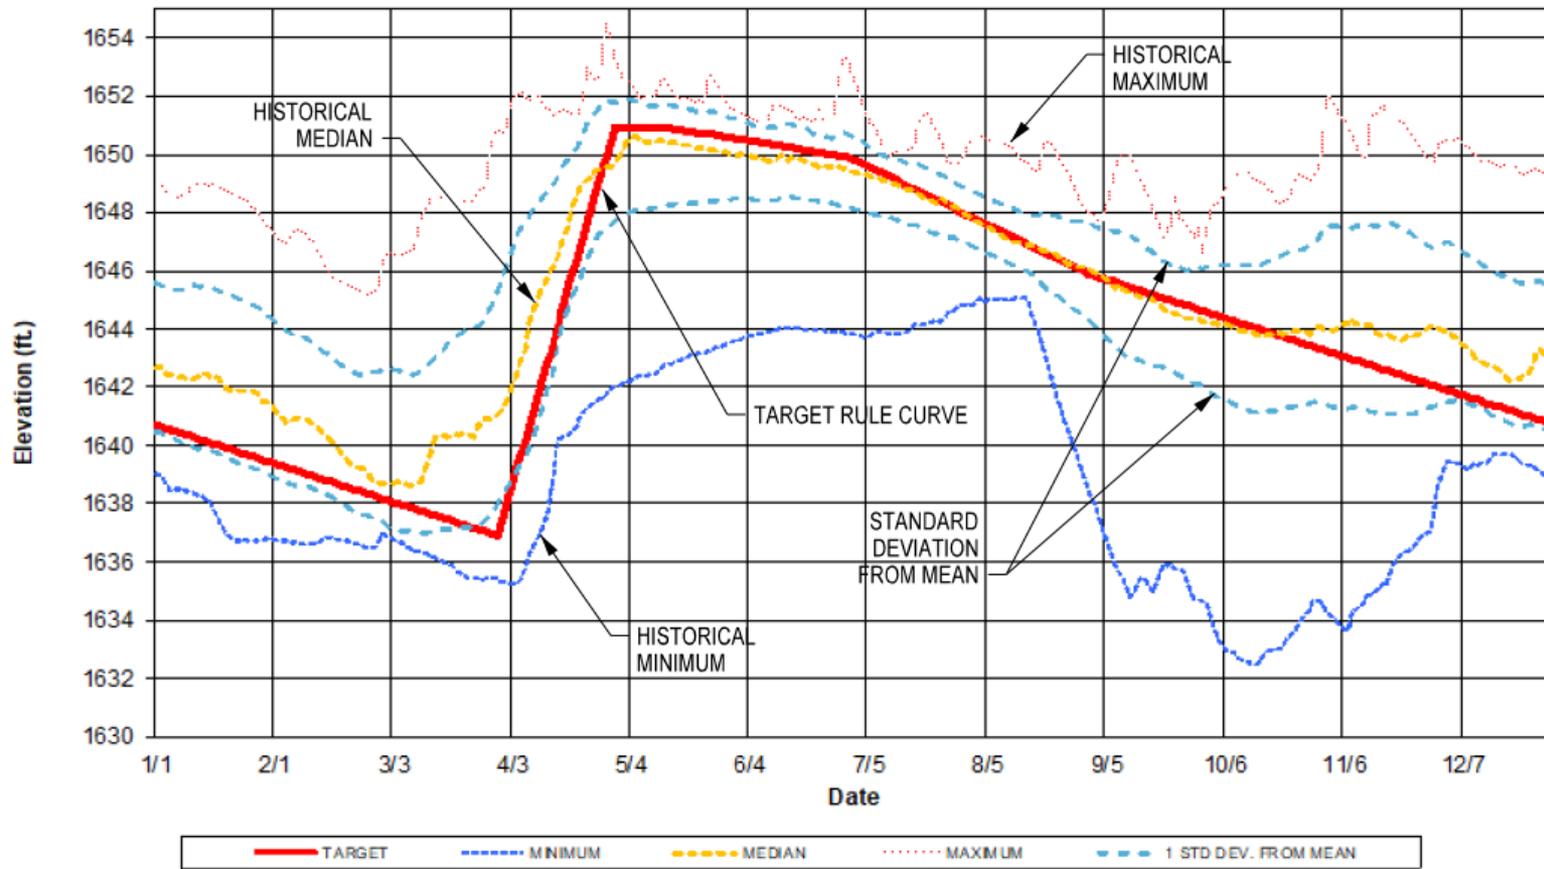
### HISTORICAL RESERVOIR WATER LEVELS (1985 - 2021)

NOTE: REFER TO WATER CONTROL NOTE 1 FOR INFORMATION REGARDING THIS CHART.
